BRANZ Type Test

FI12432-001

AS ISO 9705 & ISO 9705 FIRE TEST OF WOVEN IMAGE ECHOPANEL®

EchoPanel® 100% PET (60% recycled) polyester fibre wall panel with nominal thickness of 24 mm and nominal weight of 3000 gsm.

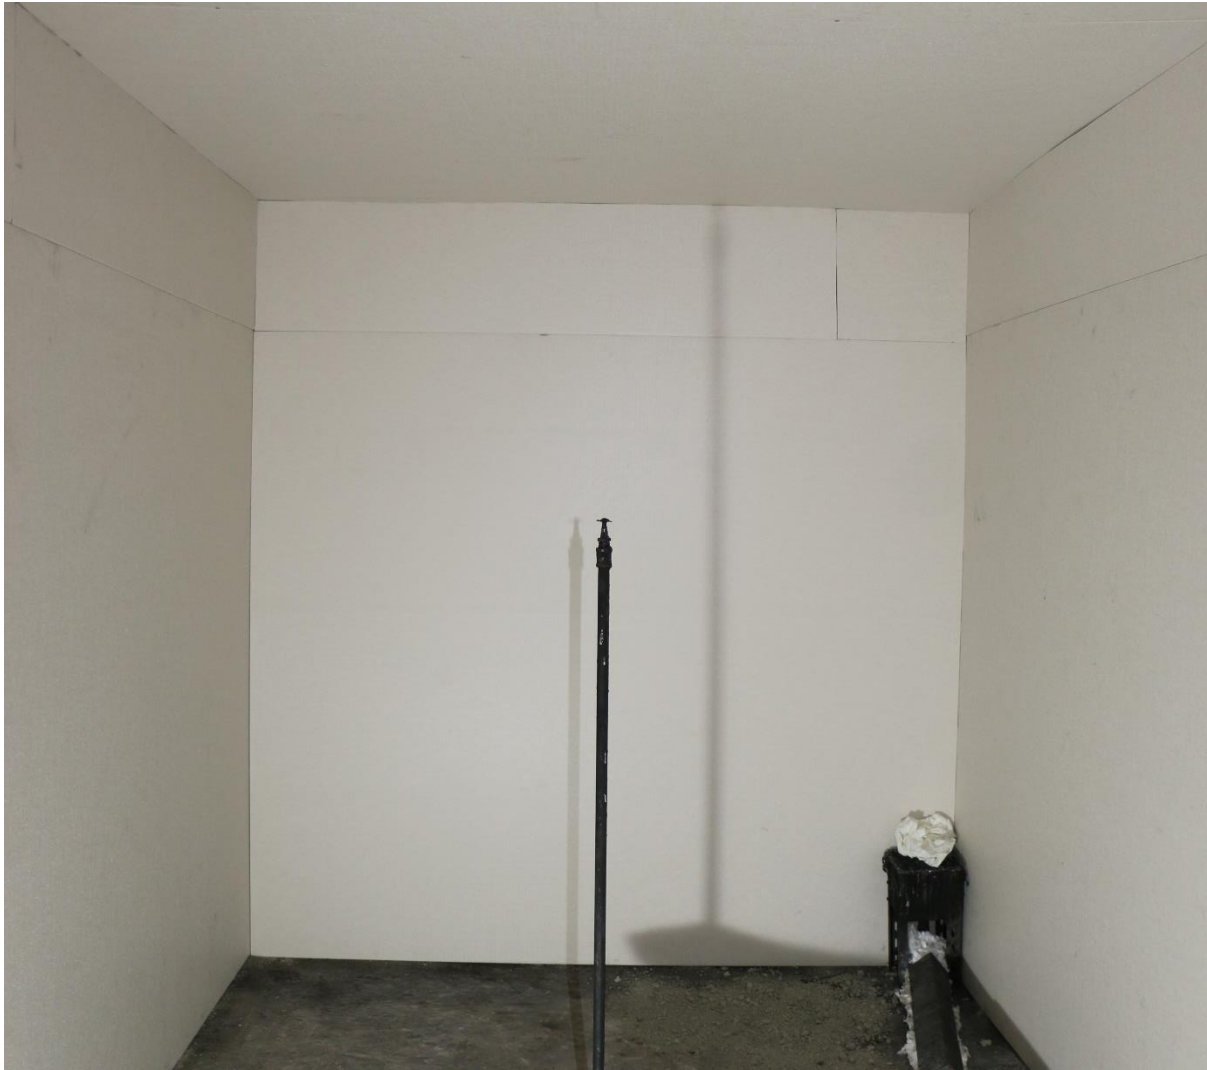
Figure 1: Completed installation

The test specimen was supplied in panels measuring 2400 mm long x 1820 mm wide x 25 mm thick. Full-sized panels were adhered horizontally along their 2400 mm edge on the lower position of three walls and across the width of the ceiling. Along the remaining upper gap of each wall a 400 mm wide strip of the test material was cut to fit.

All panels were adhered to the fibre cement substrate with H.B. Fuller Max Bond Fast Grip. The adhesive was applied in straight lines to the unexposed face of the test specimen at 200 mm spacings. Adhesive was applied around the entire perimeter of each panel 20 mm from the outer edge. Figure 1 shows the completed installation.

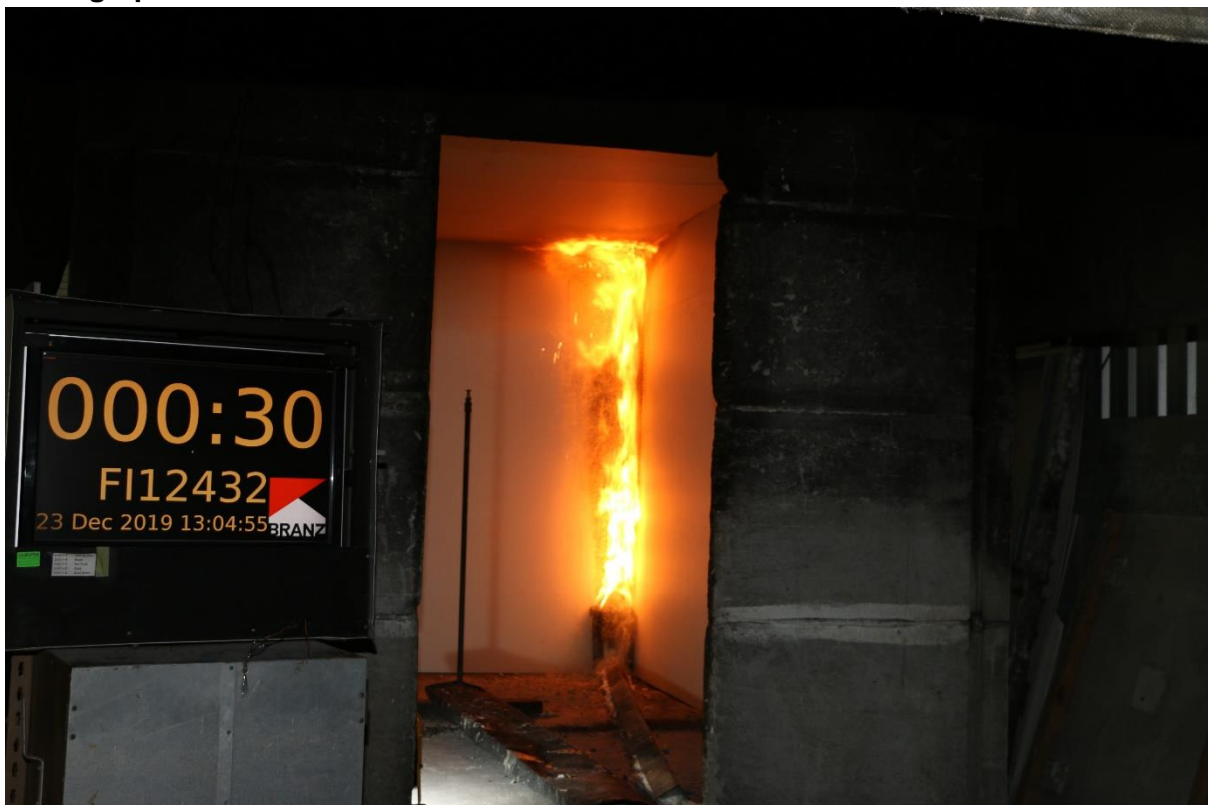
Photograph 2: At 30 seconds

Time Min:sec	Description
0:30	Flaming droplets fell from the ceiling panel, directly above the burner
2:15	The specimen began to melt back within the burner plume.

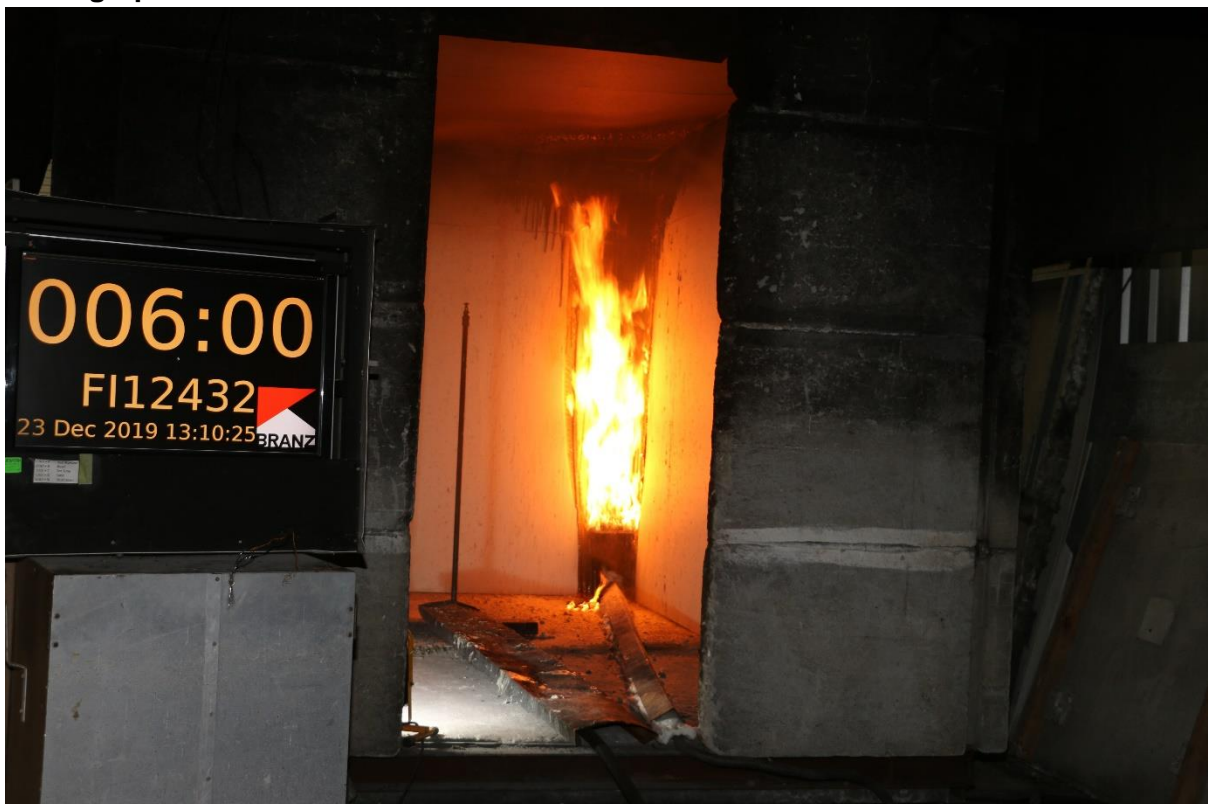
Photograph 10: At 360 seconds

5:35	Smoke began to flow at floor level from below the centre of the back-wall panel.
6:00	Material on the walls had melted back approximately 0.8 m from the corner exposing the fibre cement substrate. Molten material was dripping down the edge of the remaining material.

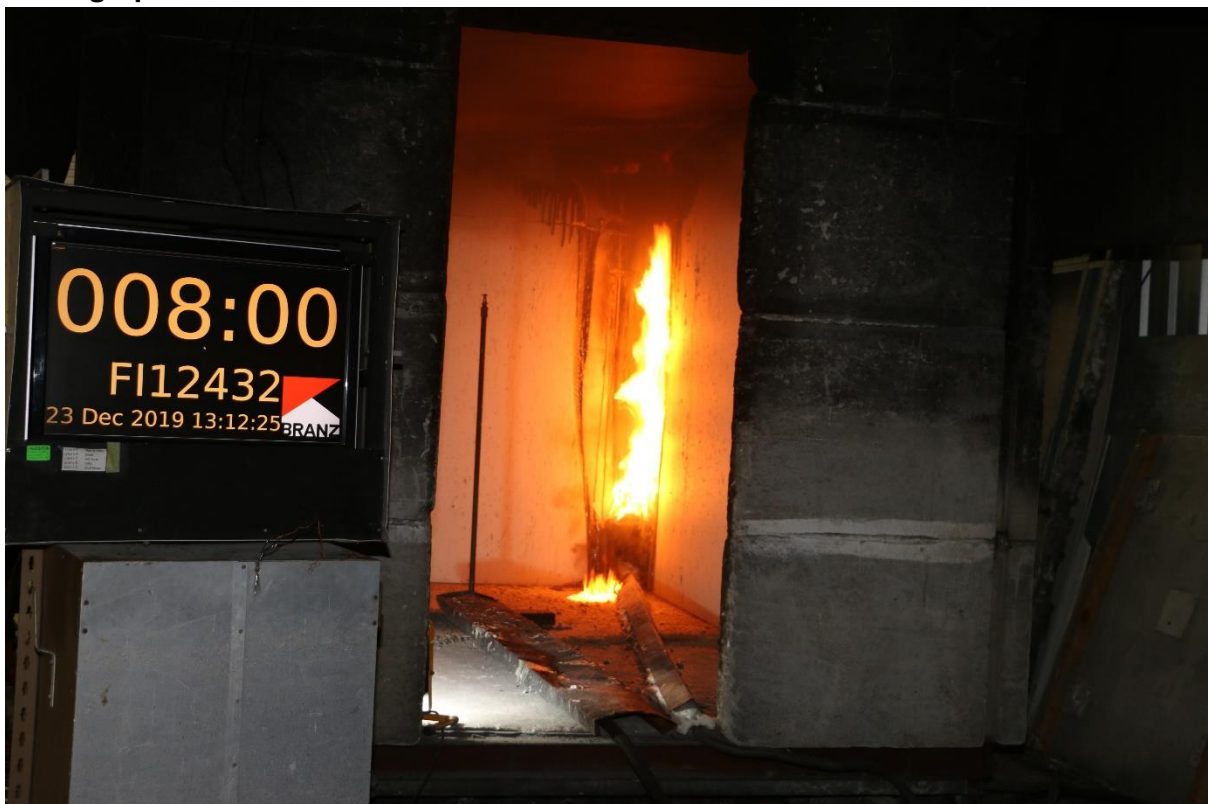
Photograph 12: At 480 seconds

7:41	All panels unaffected by direct exposure to the burner plume remained in place.
8:14	Initial liquid pool fire on the floor increased to 0.4 m diameter.

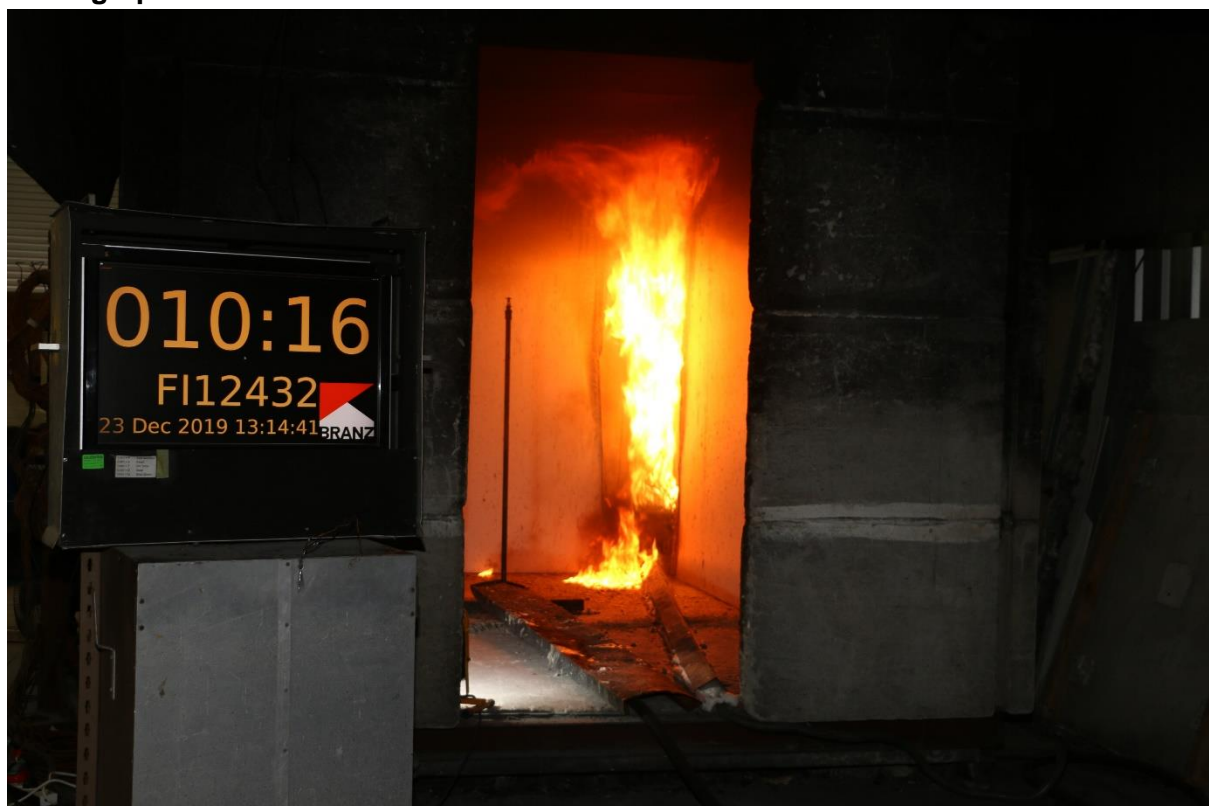
Photograph 16: At 616 seconds

8:30	Smoke density and layer thickness increased to 0.5 m from ceiling.
9:00	Smoke layer thickness increased to 0.6 m from ceiling.
10:00	Burner was increased to 300 kW.

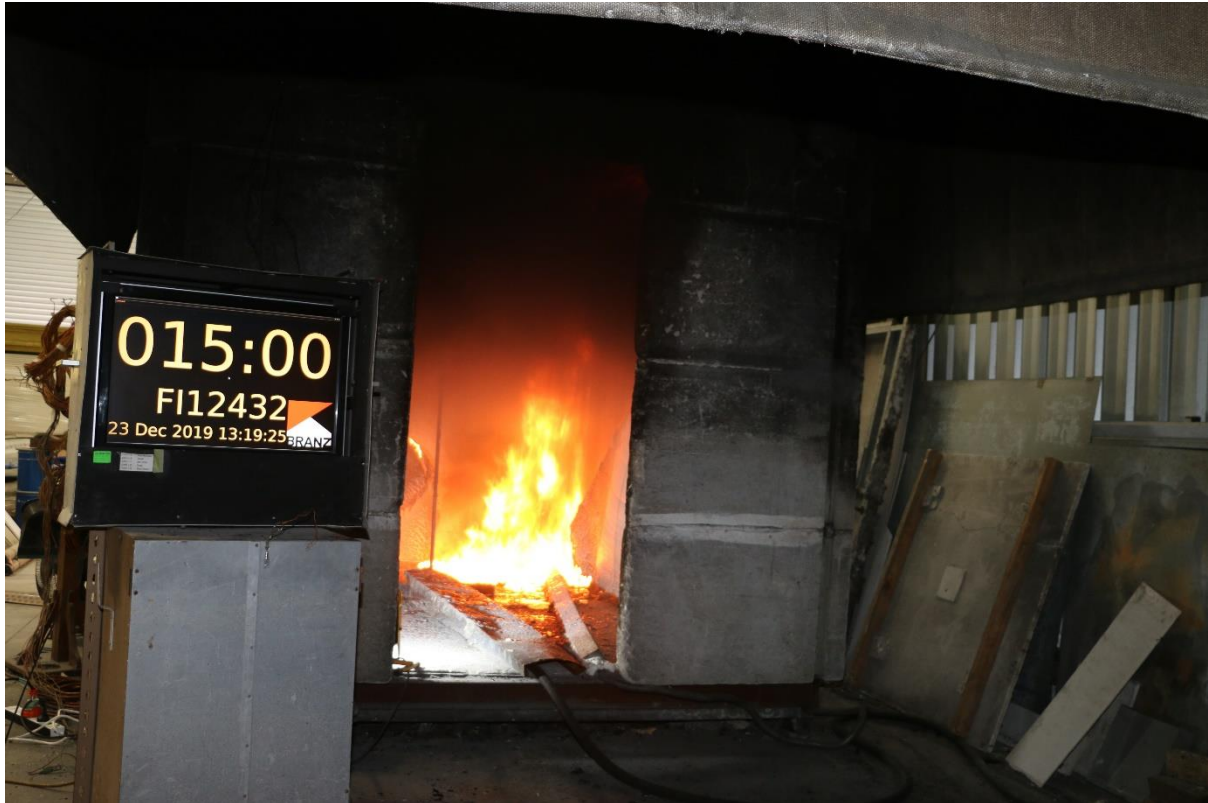
Photograph 23: At 900 seconds

15:00	The liquid pool fire fuelled by melting wall panels on either side of the burner continued to increase.
16:00	Density of the smoke layer had increased. Part of the fibre cement substrate above the burner fell down into the liquid pool fire.
