## **TEST REPORT**

Fire test of a room lined with Woven Image  
Muse 9mm PET panels, tested in accordance  
with AS ISO 9705 – 2003 R2016 and  
AS 5637.1:2015

56751500.2

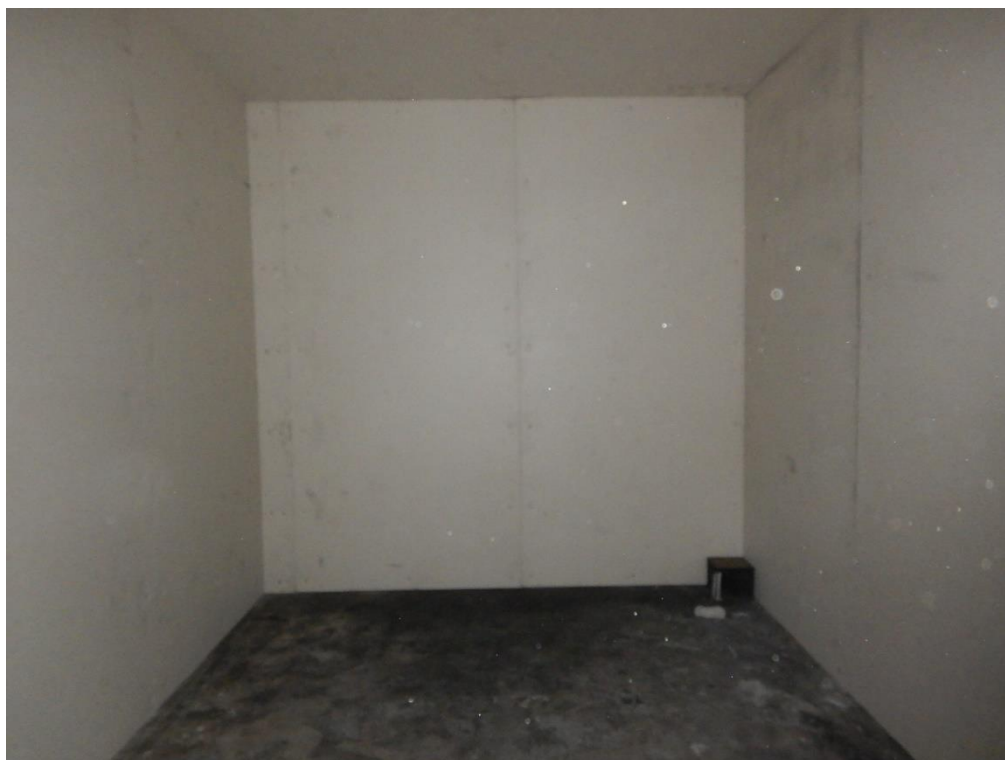
Figure A4.1. Exposed corner of the specimen before commencement of the reaction to fire test.

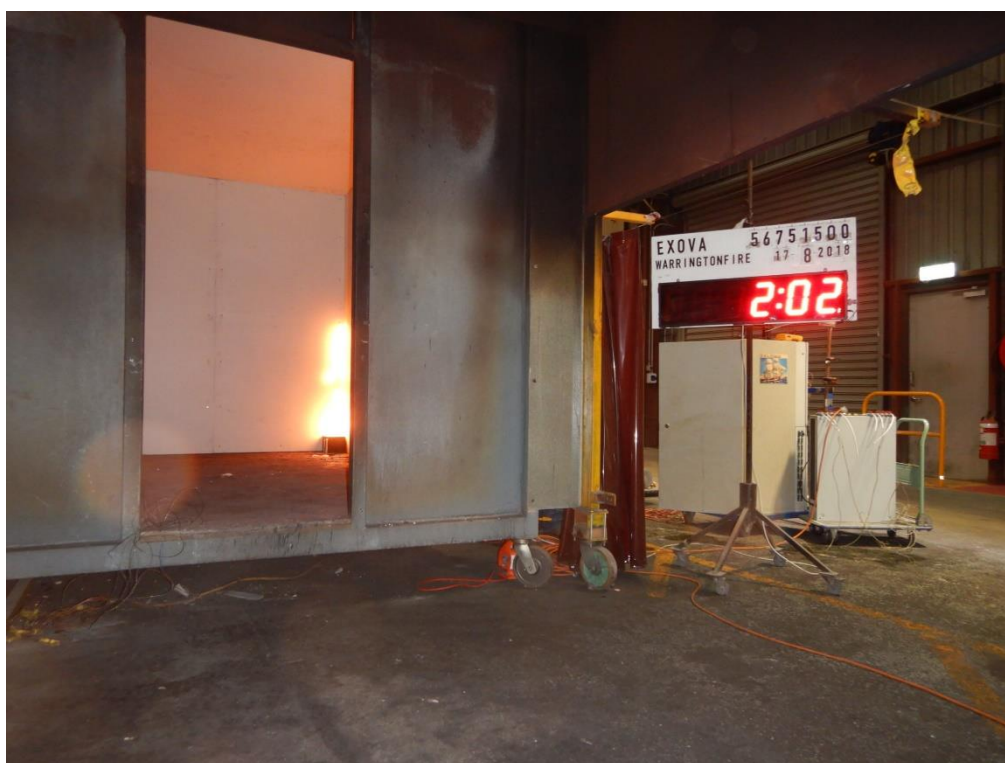
Figure A4.2 Specimen at the commencement of the fire test

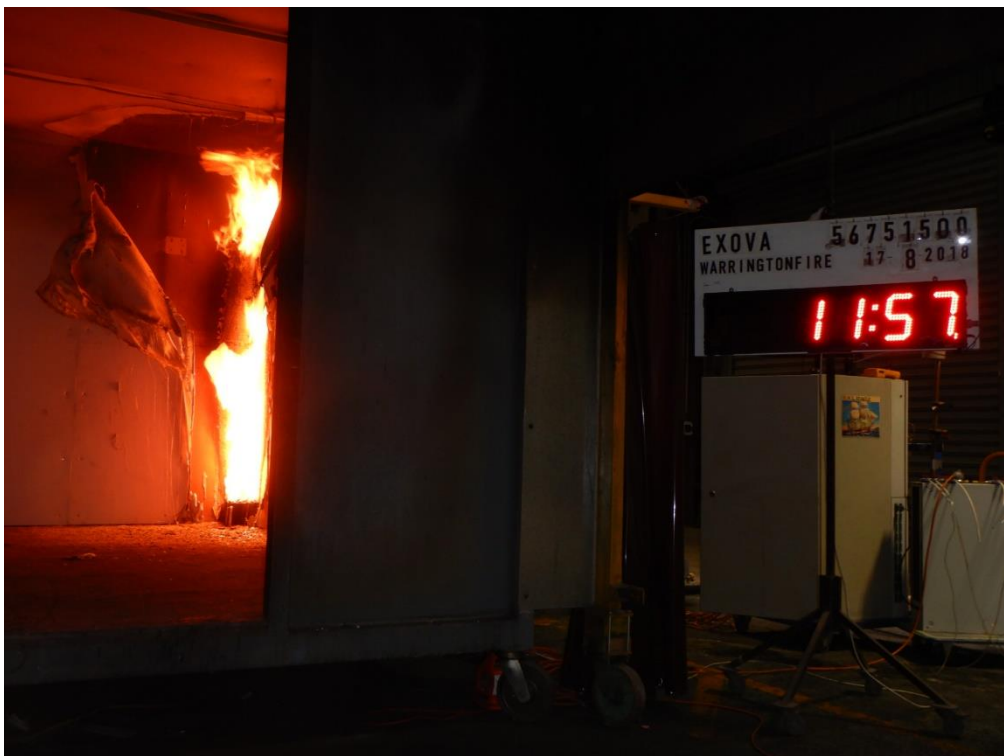
Figure A4.4 Specimen 11 minutes and 57 seconds after commencement of the reaction to fire test.

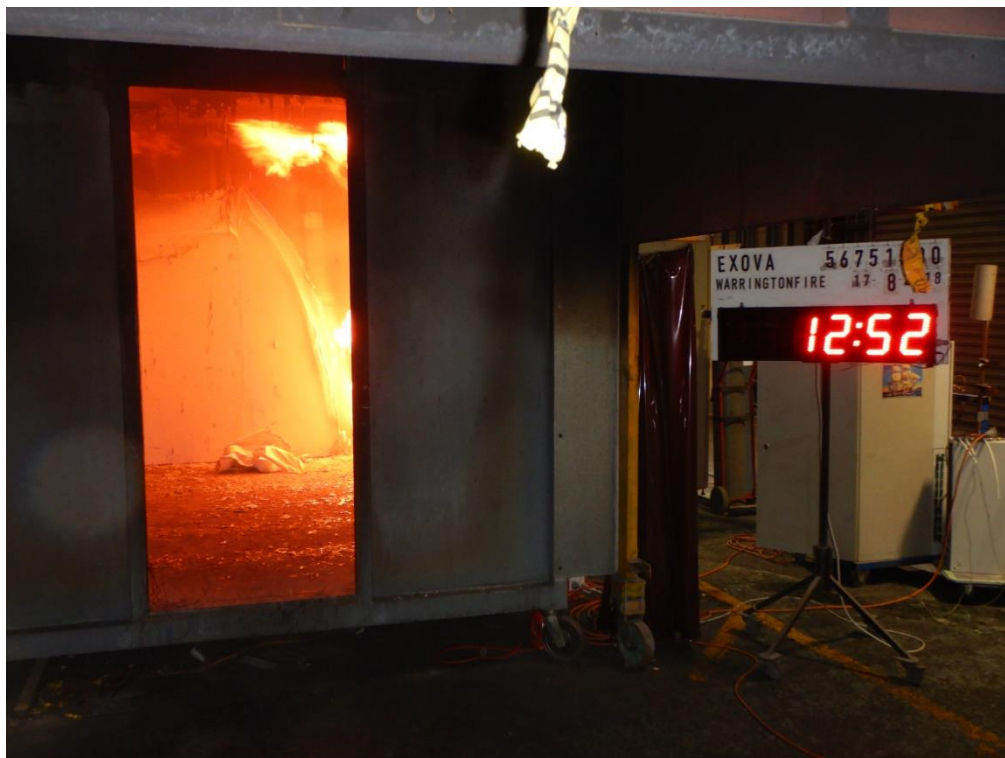
Figure A4.5 Specimen 12 minutes 52 seconds after commencement of the reaction to fire test.

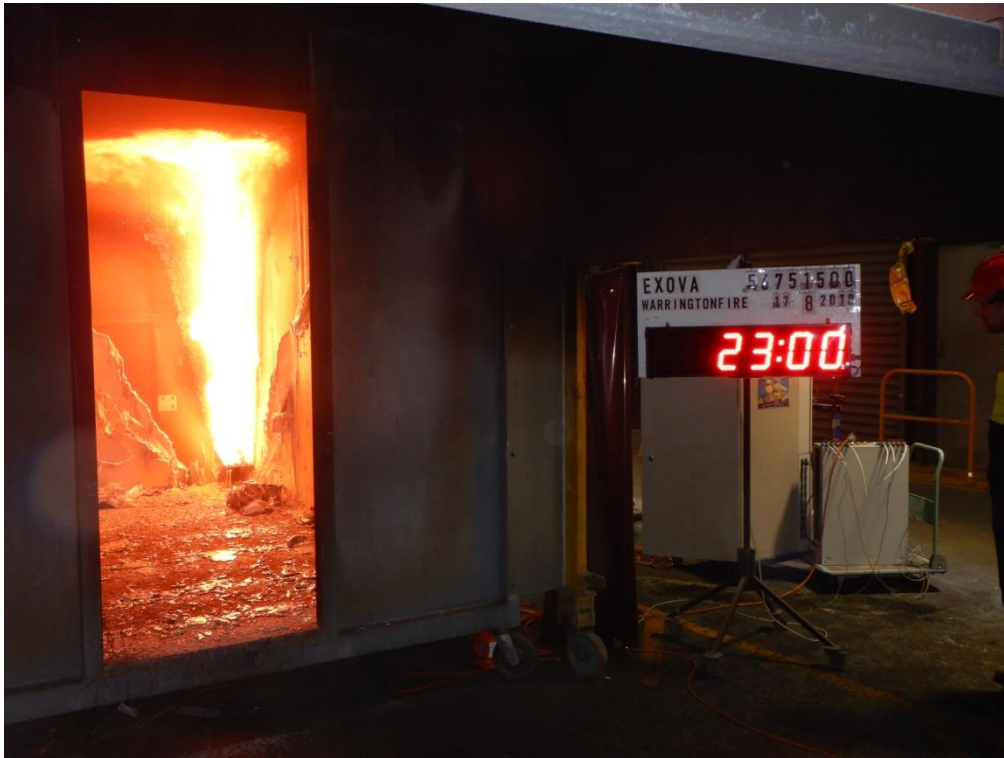
Figure A4.7 Specimen at end of test

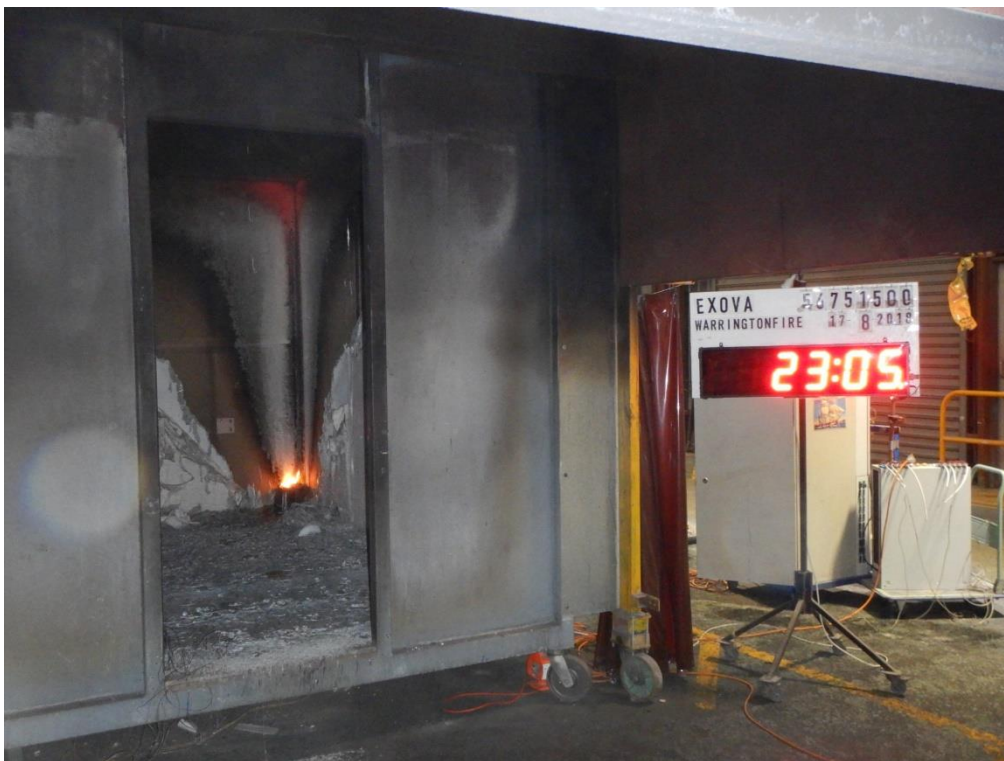
Figure A4.8 Specimen 5 seconds after burner cut off
