EchoPanel 12mm 80% Recycled

**TEST REPORT
AS ISO 9705:2003**

IGNL-8187-06-01R I01 R00

Tested: 23.05.2024
Issued: 19.06.2024
Expiry: 18.06.2029

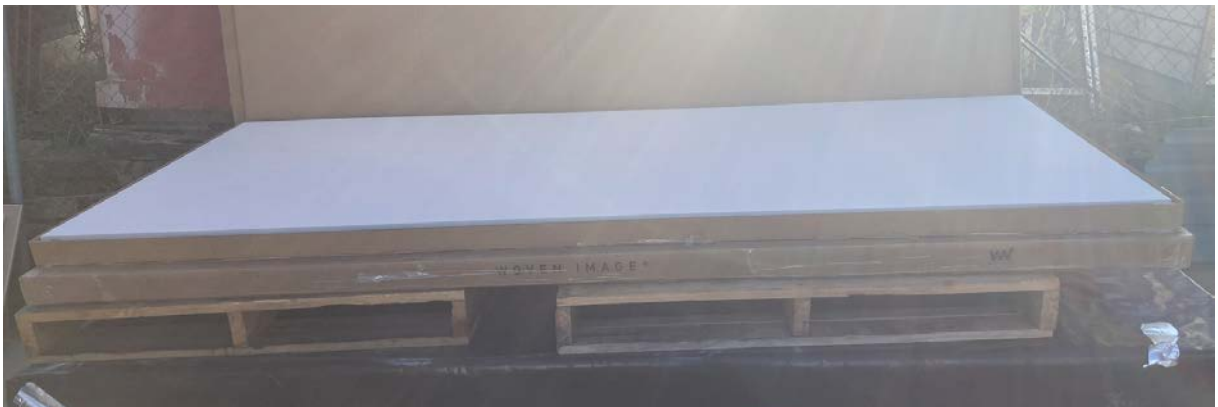
FIGURE 1:

The received specimens were symmetrical white rigid insulation panels with a measured width of approximately 1200 mm and a measured length of approximately 2800 mm. They had a measured nominal thickness of 11.76 mm. At the request of the sponsor, the panels were fabricated to the dimensions suitable for the room test by Ignis Labs.

SPECIMEN PANELS

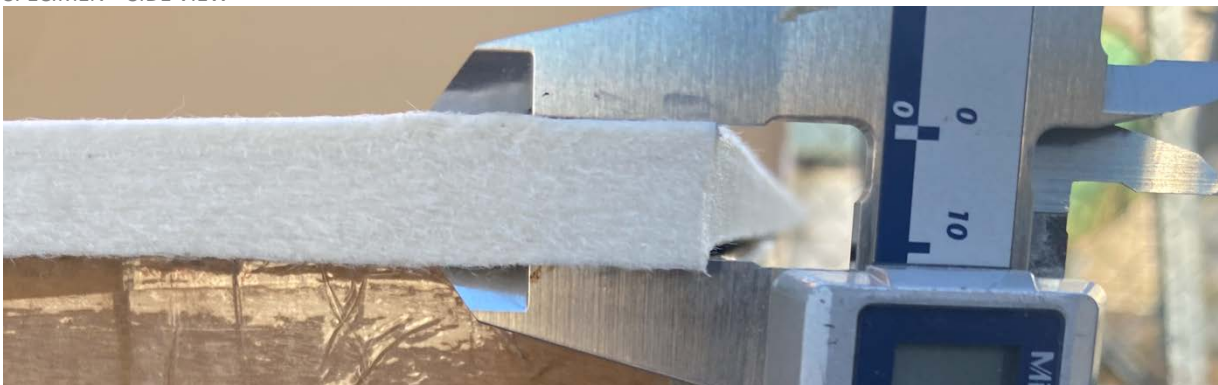
FIGURE 2:

The panels were fixed to the test room using HB Fuller Max Bond Fast Grip adhesive applied in thin beads which were spaced approximately 200 mm apart across the width of unexposed face of each panel. The panels were installed vertically and allowed to cure for two days before testing.

SPECIMEN – SIDE VIEW

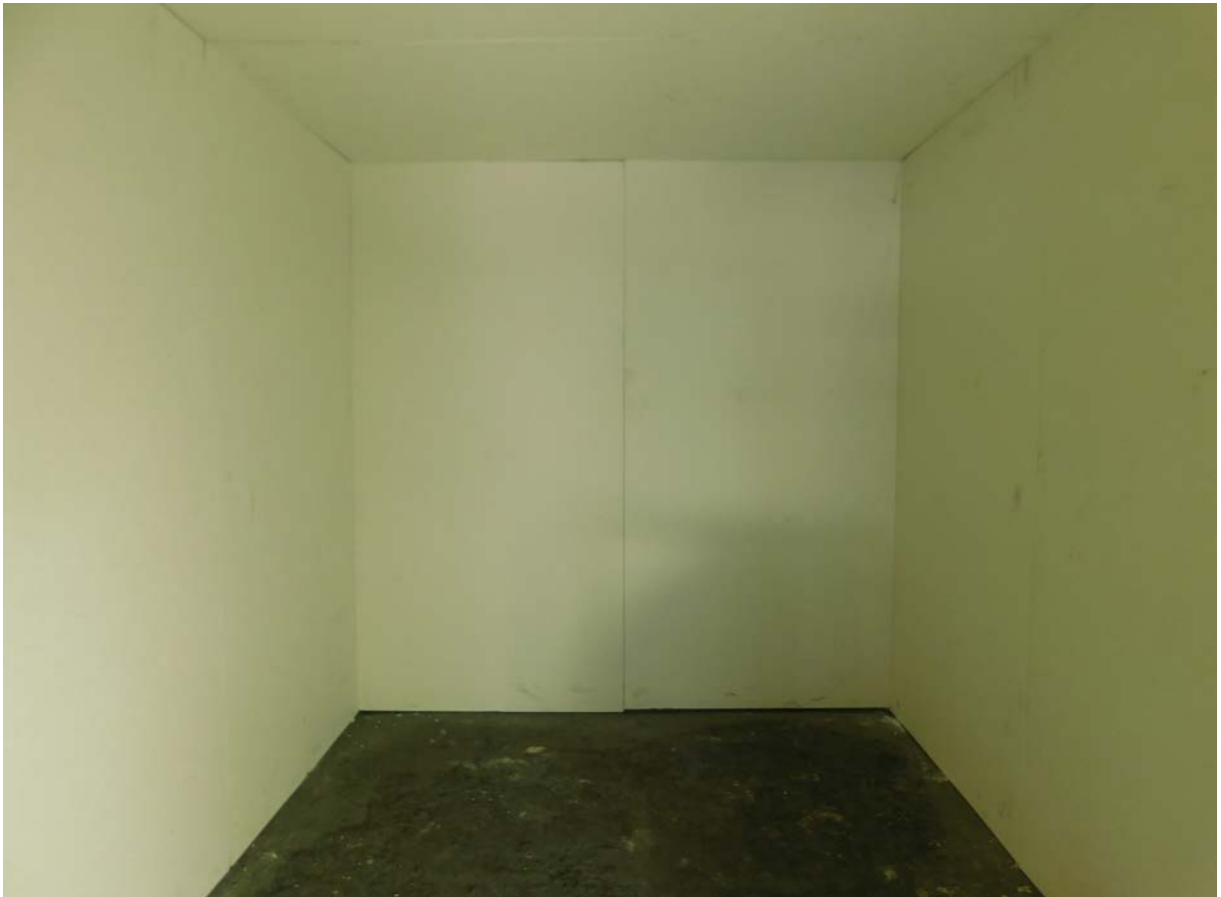
FIGURE 3:

The panels were fixed to the test room using HB Fuller Max Bond Fast Grip adhesive applied in thin beads which were spaced approximately 200 mm apart across the width of unexposed face of each panel. The panels were installed vertically and allowed to cure for two days before testing.

SPECIMEN INSTALLATION

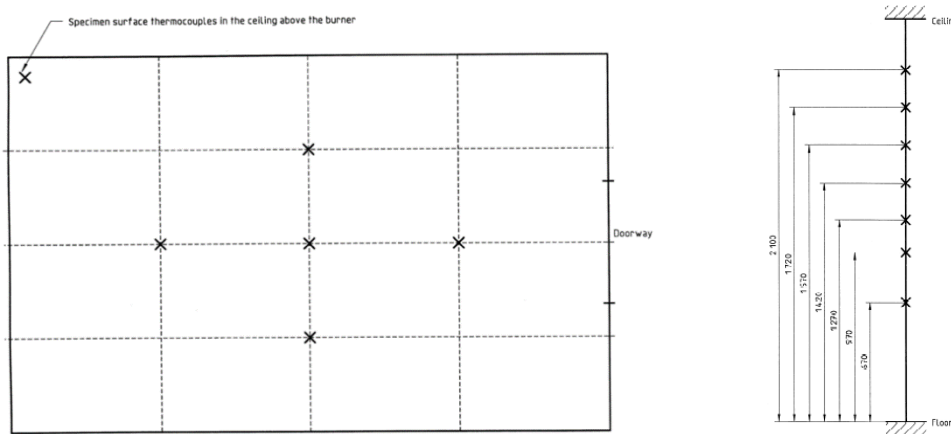
FIGURE 4:

The temperature within the room was measured via a series of thermocouples located within a tree nature.

The location of the ceiling thermocouples as well as the thermocouple tree is detailed below.

THERMOCOUPLE LOCATION

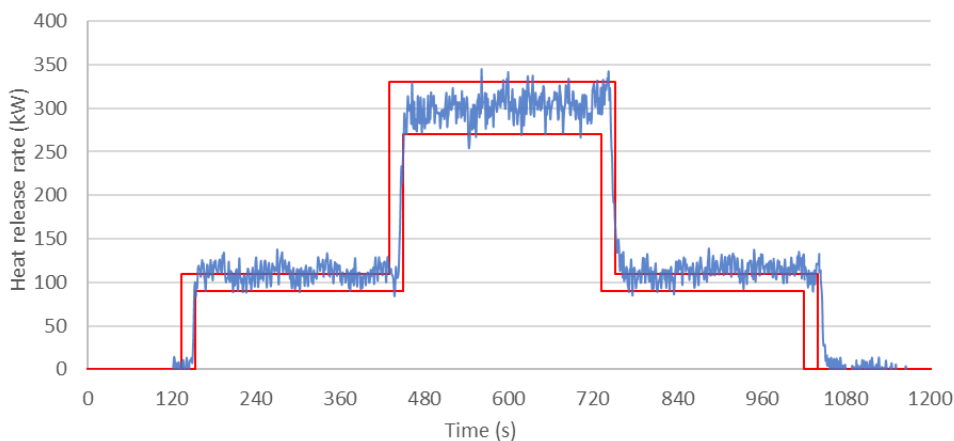
FIGURE 5:

A calibration test was carried out prior to the testing of the specimen. The gas burner was placed directly under and 100 mm below the exhaust hood and the gas supply to the burner was adjusted such that the power output from the burner was 0 kW for 2 minutes, then 100 kW for five minutes then 300 kW for a further five minutes, then 100 kW for five minutes and finally 0 kW for two minutes, after which time the calibration test was stopped. Data from instruments was collected and analysed every second.

CALIBRATION

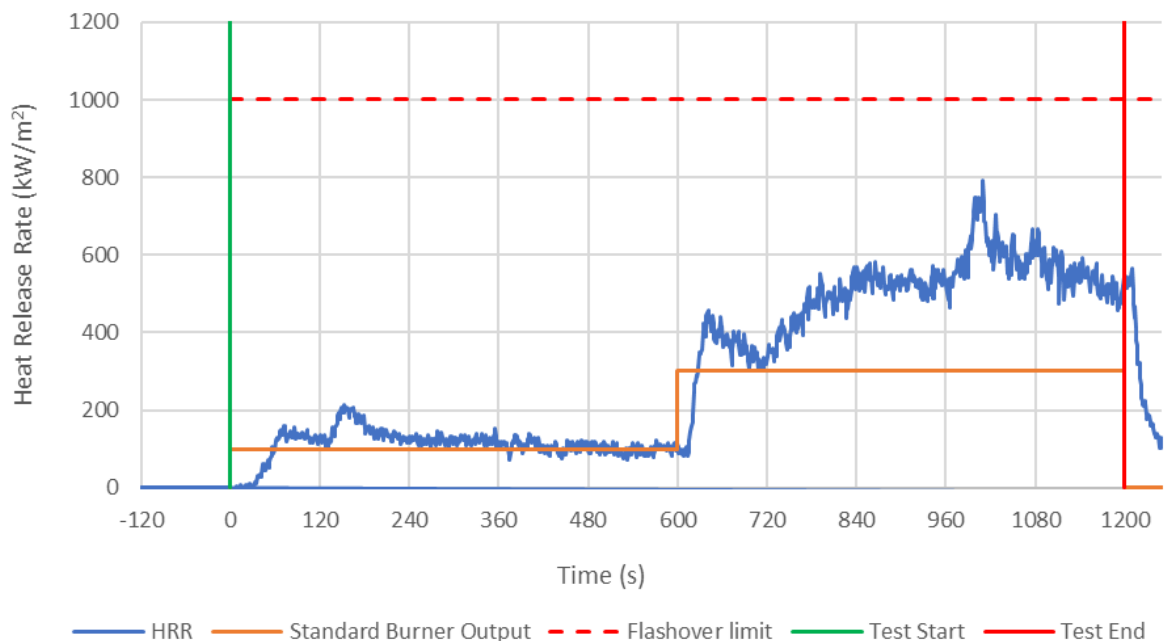
FIGURE 6:

The heat release rate during the test is shown in the figure below. The heat release did not exceed the flashover limit of 1 MW during the test.

HEAT RELEASE RATE MEASUREMENTS

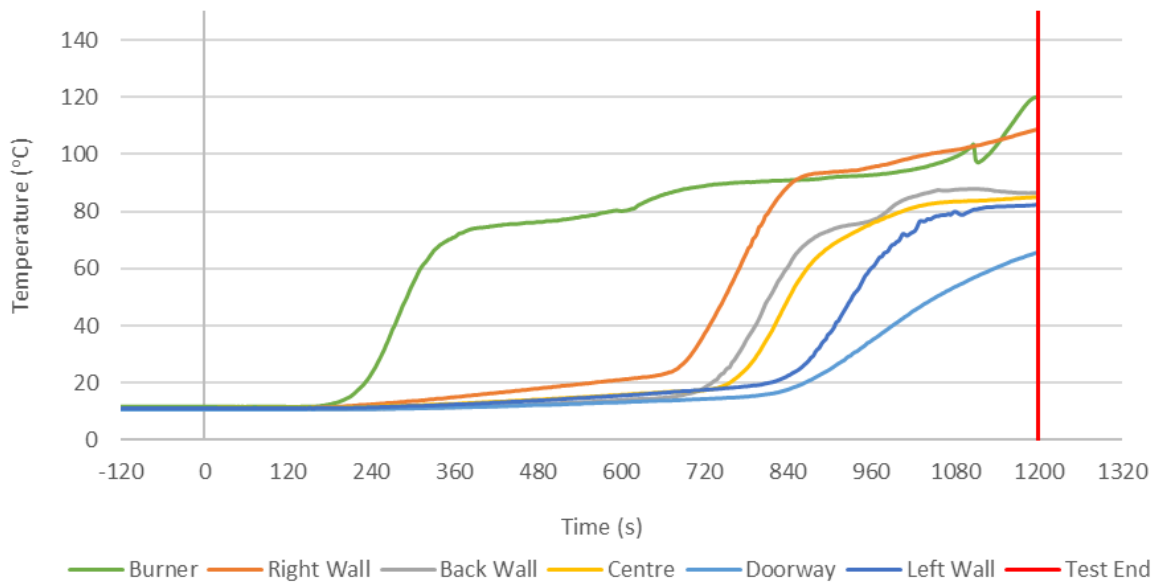
The thermocouple detail shows the impact of increasing the flame size. It should be noted that the temperature of the thermocouples installed at various points in the ceiling around the room do not significantly increase temperature until approximately 180 seconds after the burner is increased to 300 kW because there was a time lag between the spread of flame and the increase in burner temperature.

FIGURE 7:
THERMOCOUPLE MEASUREMENTS – CONCEALED CEILING

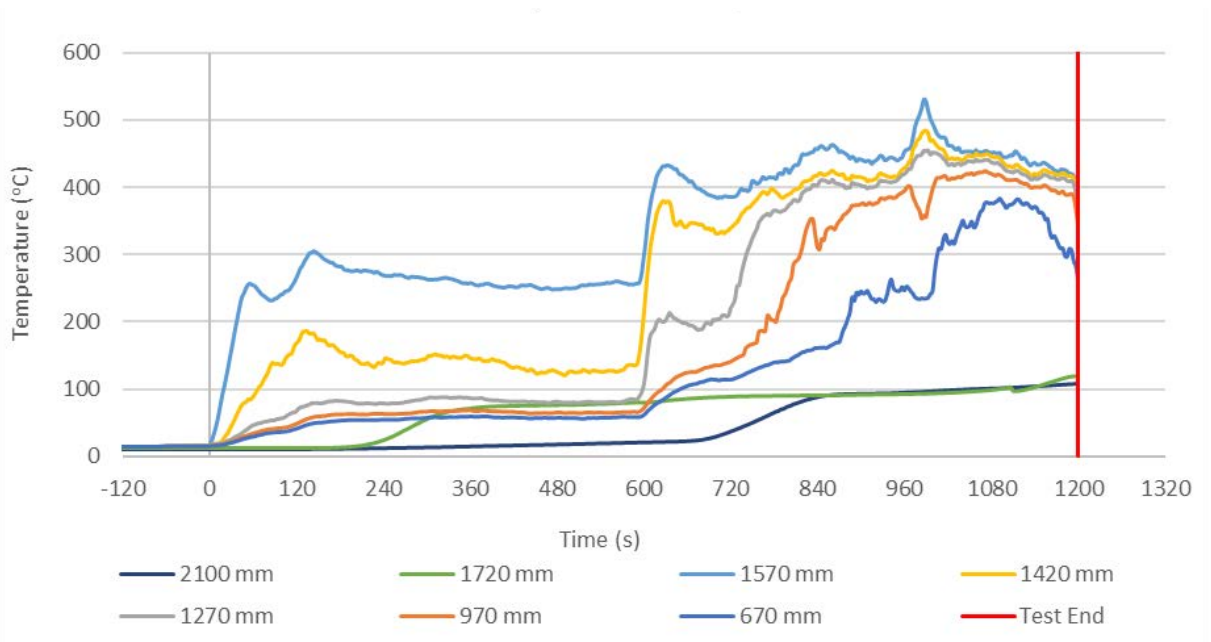
Based on the nature and intent of the tests, the thermal conditions within the room as measured by the thermocouples. The temperatures in the room for the two trees are detailed below.

FIGURE 8:
THERMOCOUPLE MEASUREMENTS – THERMOCOUPLE TREE

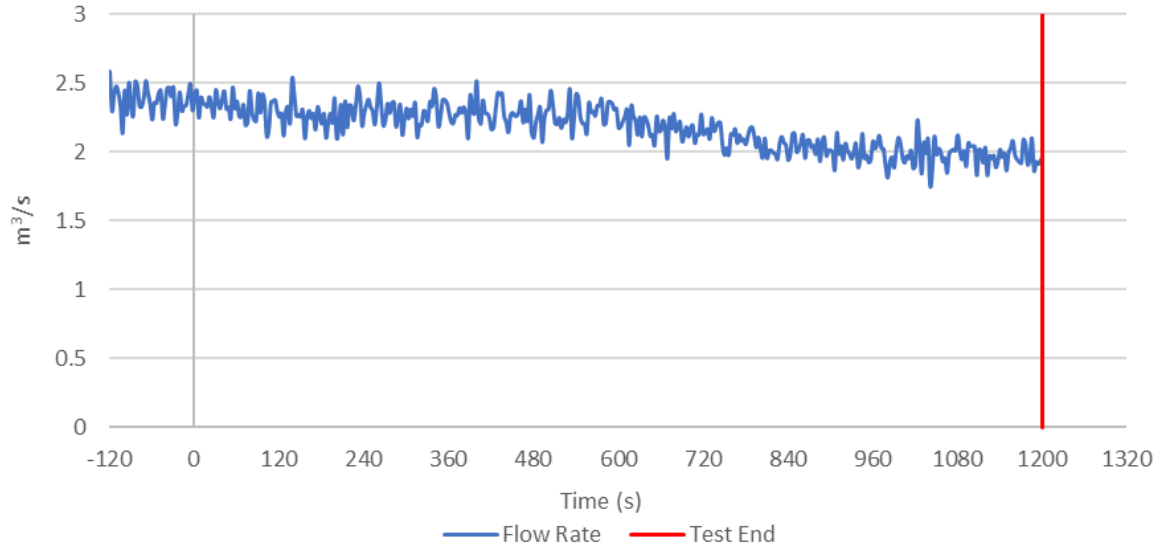
FIGURE 9:

The volume flow rate was measured with a bidirectional pressure probe attached to a differential pressure transducer with a Type K thermocouple located adjacent to the probe.

VOLUME FLOW RATE MEASUREMENTS

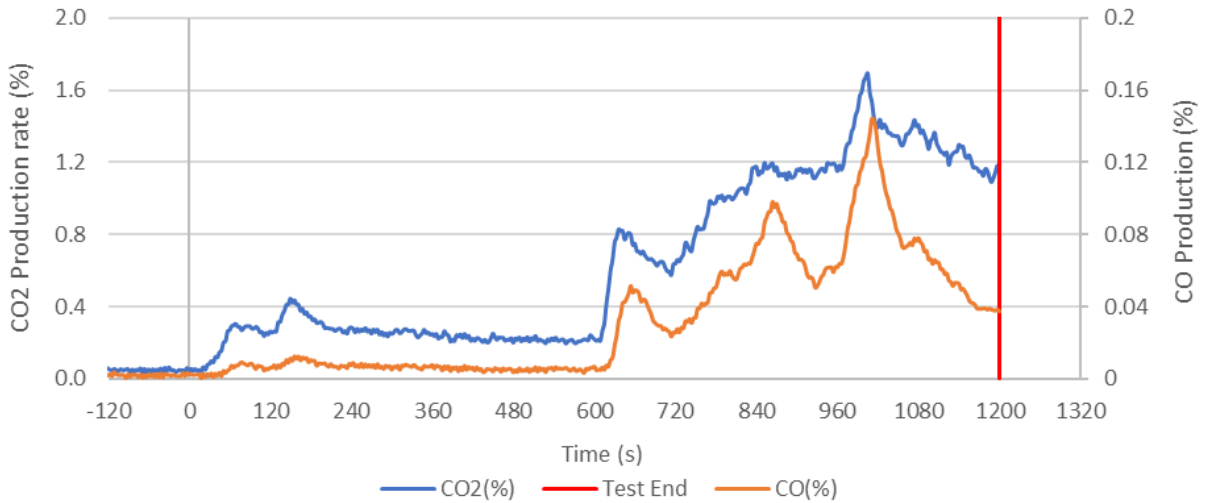
FIGURE 10:

An exhaust sampling probe sampled the combustion products which were analysed by a Servomex Servopro 4000 series analyser. Oxygen concentration during the test was determined by the paramagnetic oxygen analyser, whilst the carbon monoxide and carbon dioxide concentrations were determined within the Servopro 4000 analyser.

CARBON DIOXIDE AND CARBON MONOXIDE PRODUCTION

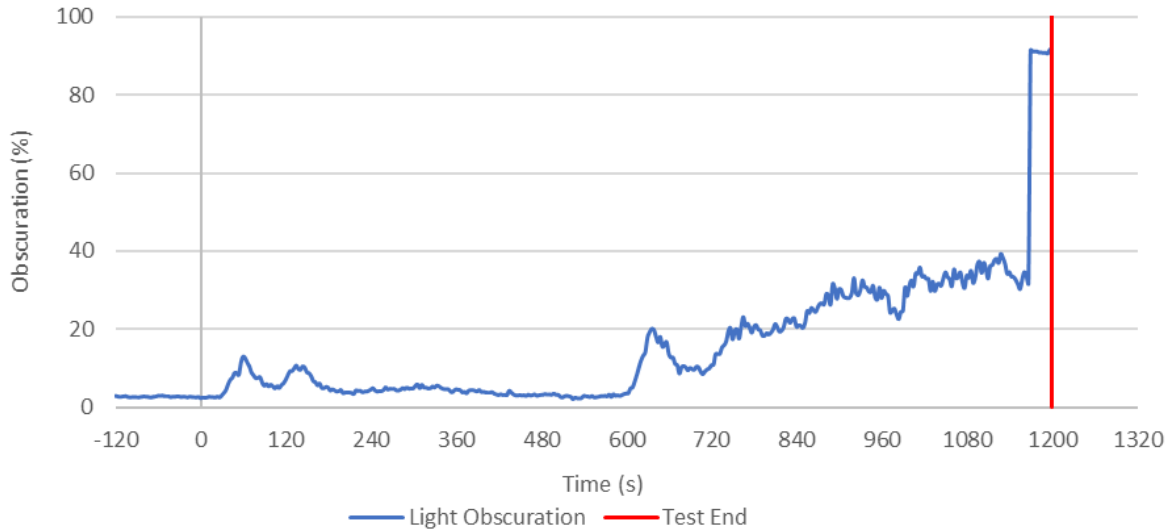
FIGURE 11:

Heat flux at the floor was not measured. The optical density of the smoke was determined by measuring the light obscuration with a system consisting of a laser lighter, lenses, an aperture and a photocell. No other variations to the test criteria were recorded.

LIGHT OBSCURATION MEASUREMENTS

The smoke production and smoke obscuration measurements spiked approximately 19 minutes into the test. This may have been caused by debris getting caught in the detection system.

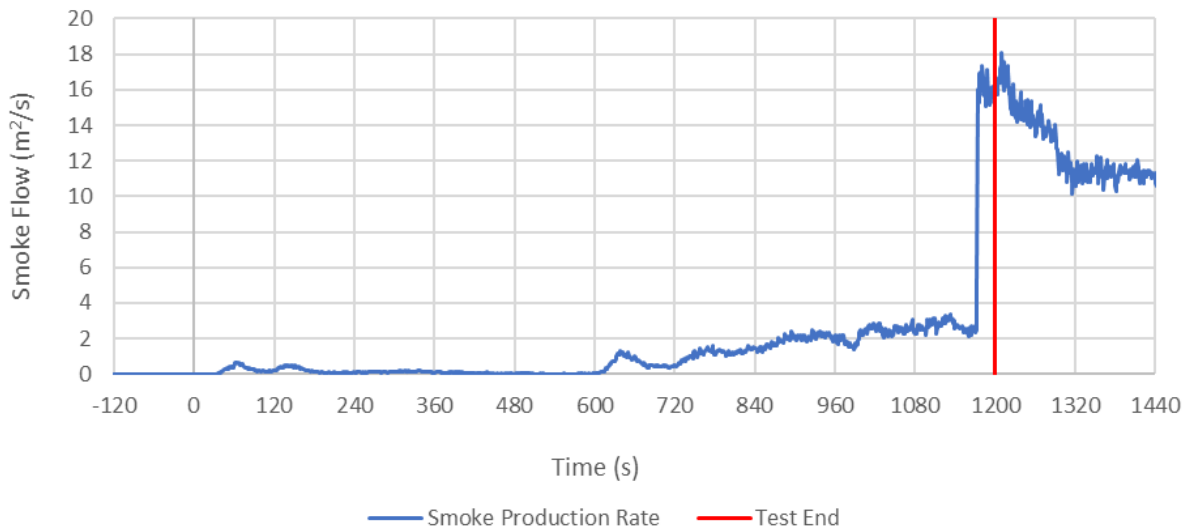
FIGURE 12:

SMOKE PRODUCTION MEASUREMENTS

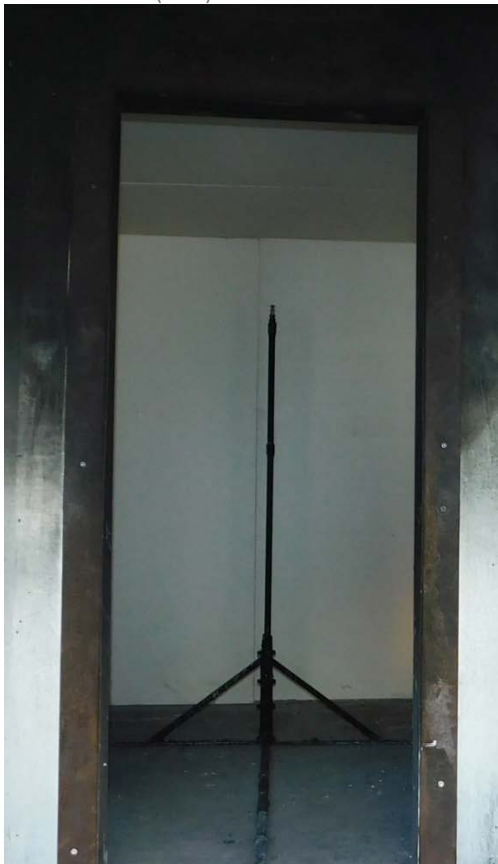
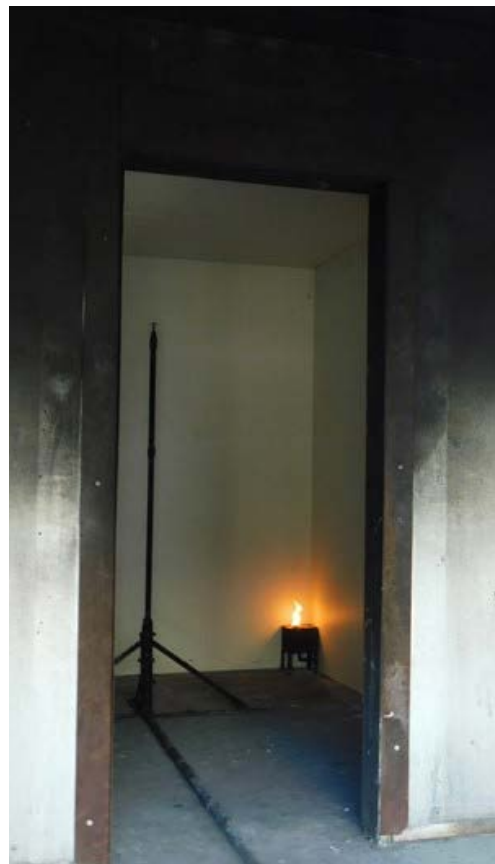
FIGURE 13:

START OF TEST (0:00)

01:00 INTO THE TEST

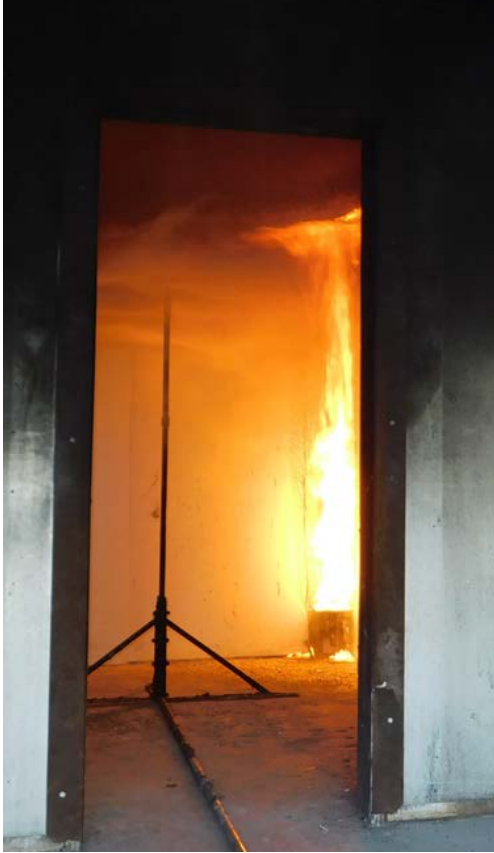
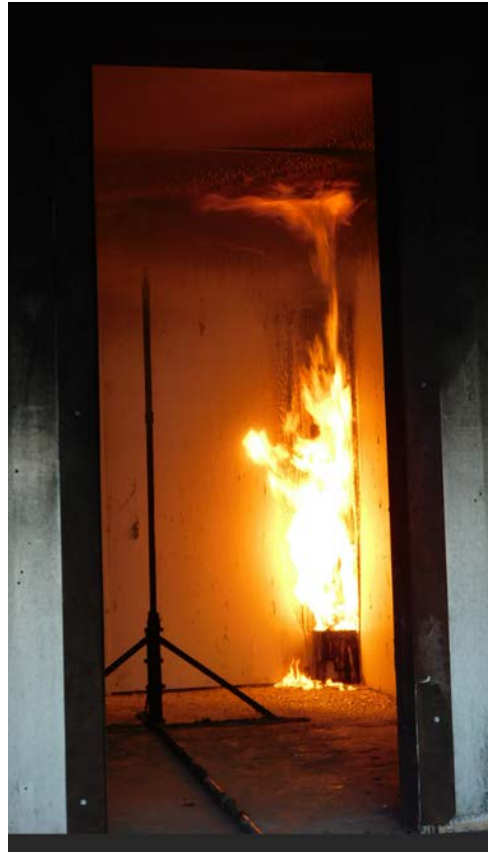
FIGURE 14:

04:20	Debris from the ceiling starts forming puddles on the floor.
05:00	Puddle fire forms around burner.
05:15	Wall on left hand side (towards the back of room) begins melting and back ceiling sheet begins falling.

04:00 INTO THE TEST

04:26 INTO THE TEST

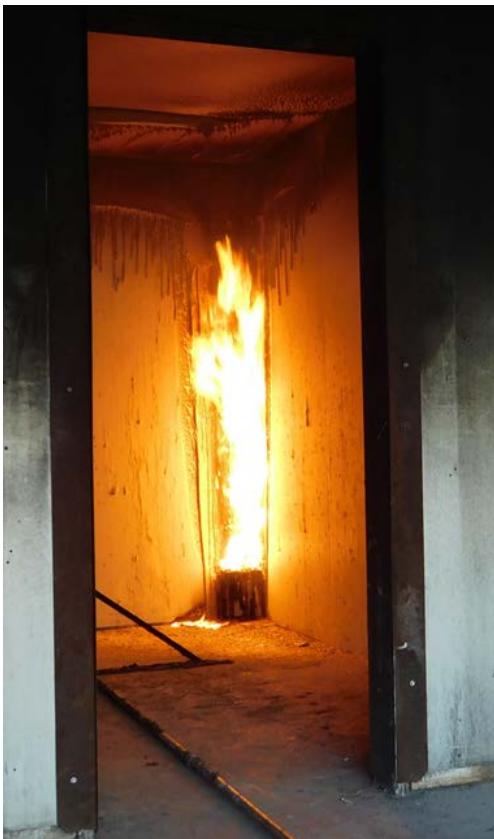
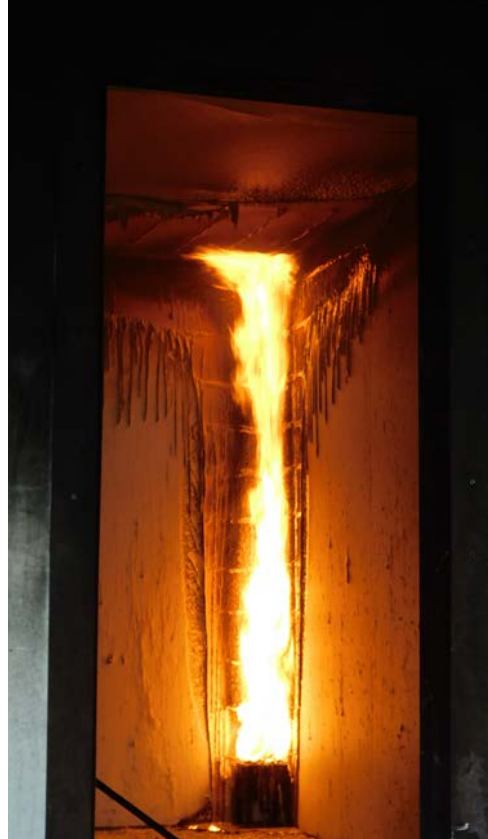
FIGURE 15:

06:00	Wall on left hand side back panel begins charring and begins to peel of the wall.
07:00	Melting across the top of the entire back wall.
07:30	Ceiling panels begin to bulge.

07:05 INTO THE TEST

10:00 INTO THE TEST

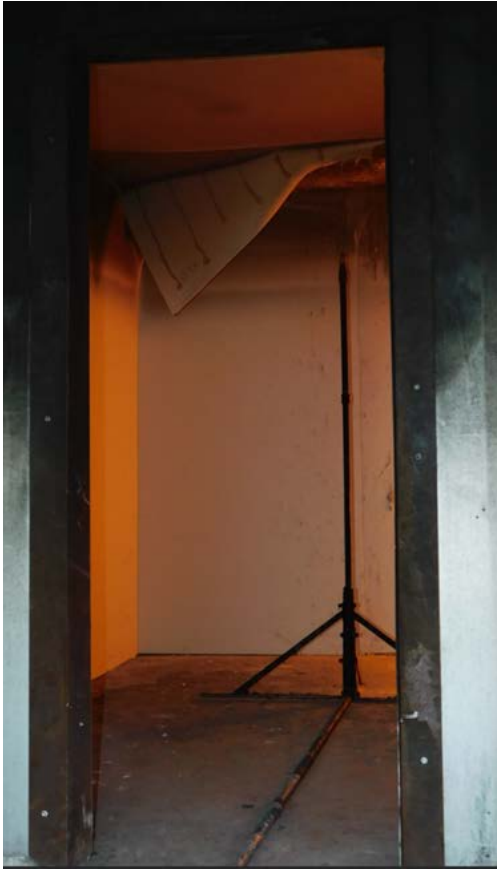
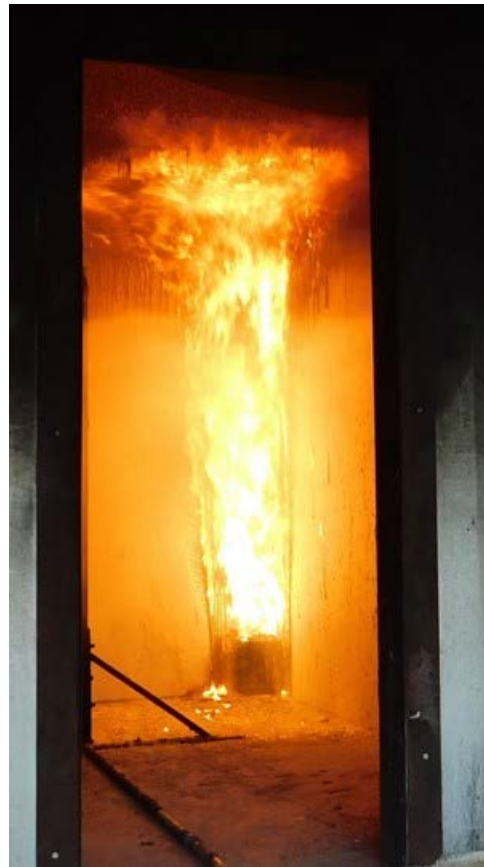
FIGURE 16:

10:40	Ceiling back panel collapses.
12:10	Burner set to 300 kW and ceiling continues to melt as fiery droplets fall from ceiling.
12:30	All sheets in room begin to bulge, heavy black smoke emerges from room and smoke inside room thickens.

10:41 INTO THE TEST

12:25 INTO THE TEST

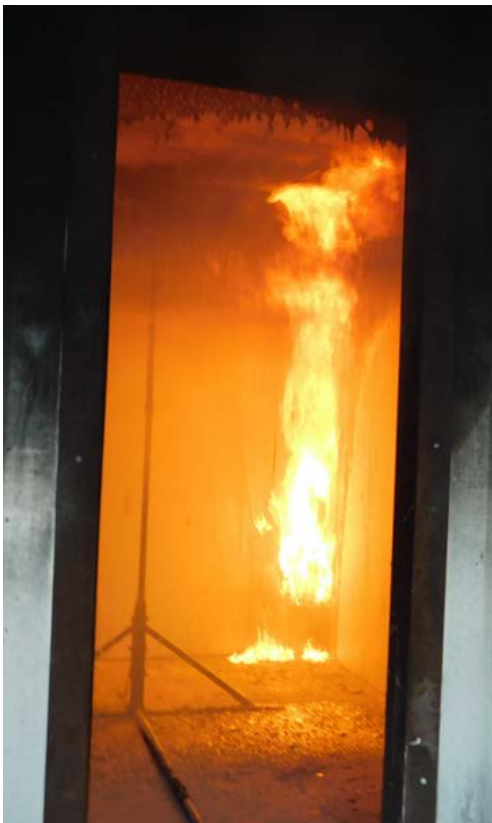
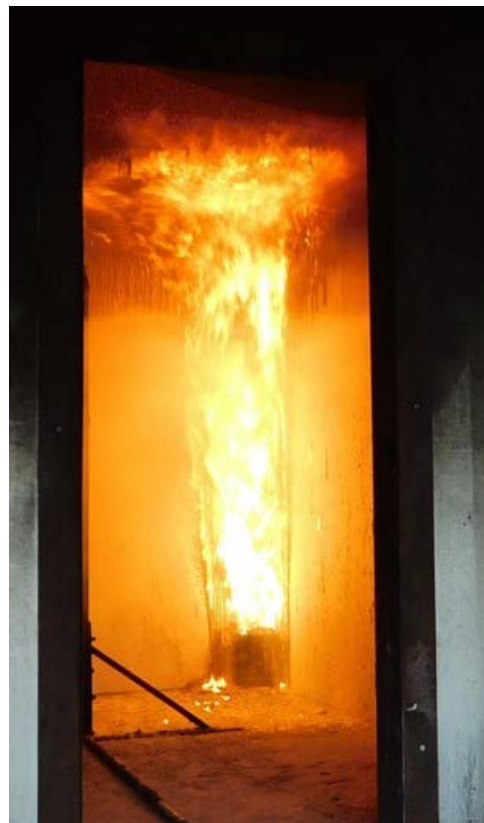
FIGURE 17:

13:00	Entire ceiling starts melting and glue lines along ceiling exposed.
13:30	All panels on left hand side of wall begin to melt and puddle fire around burner grows.

13:12 INTO THE TEST

14:31 INTO THE TEST

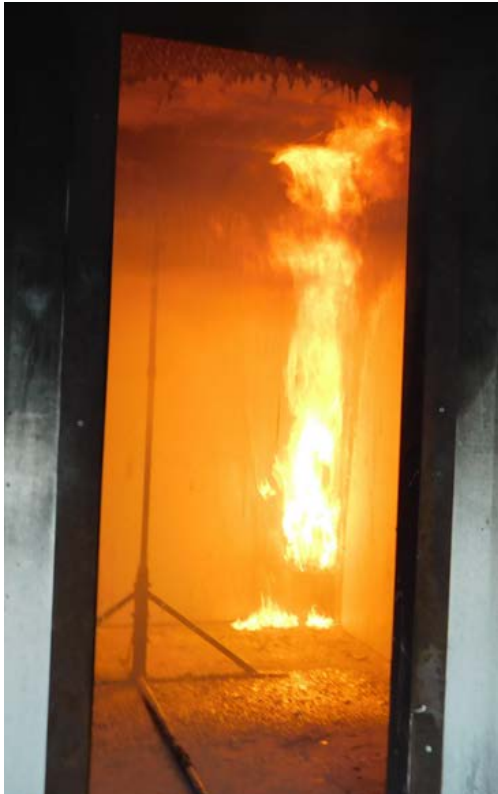
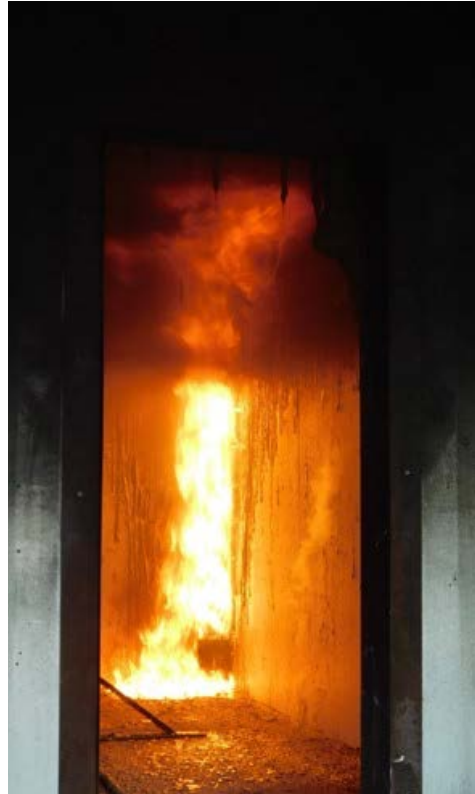
FIGURE 18:

15:00	Puddle fire around burner continues growing and dripping in front of door.
15:15	Ceiling begins collapsing.
15:30	Right hand side wall on fire and fiery droplets begins falling from ceiling.

14:49 INTO THE TEST

16:28 INTO THE TEST

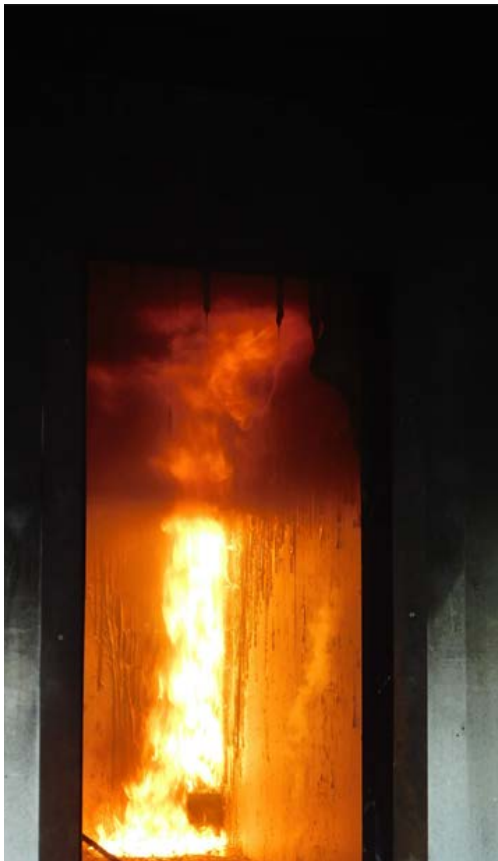
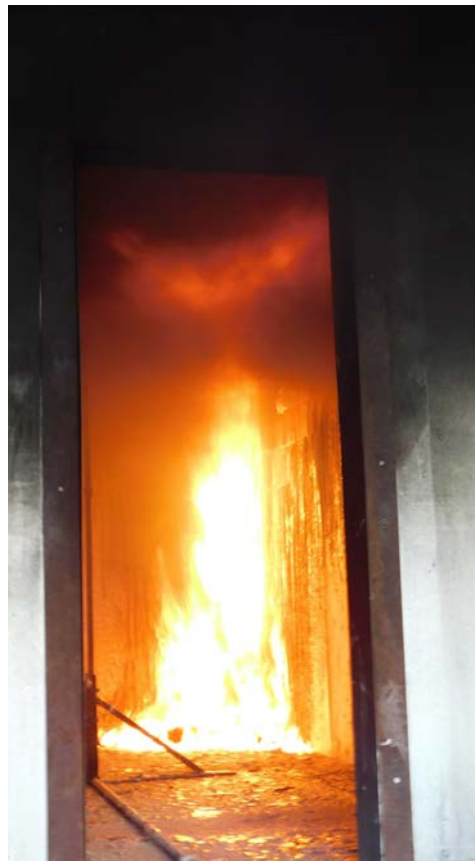
FIGURE 19:

16:44 INTO THE TEST

17:17 INTO THE TEST

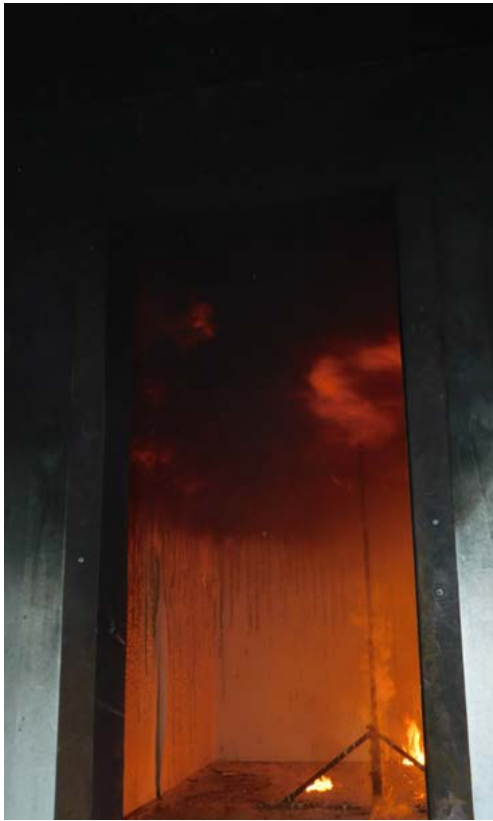
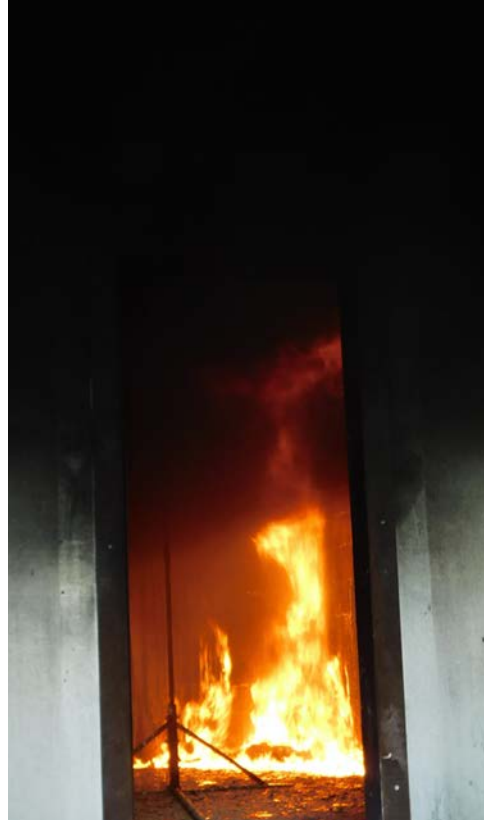
FIGURE 20:

18:45	Flames present on ceiling and puddle fire around burner reaches halfway across the back of the room.

19:00	Smoke thickens to an even blacker colour and fiery droplets continue falling from ceiling.
19:30	Puddle fire forms in the middle of the floor (separate to puddle fire around burner).
22:10	Burner switched off.
23:20	Fire extinguished.

18:17 INTO THE TEST

20:30 INTO THE TEST

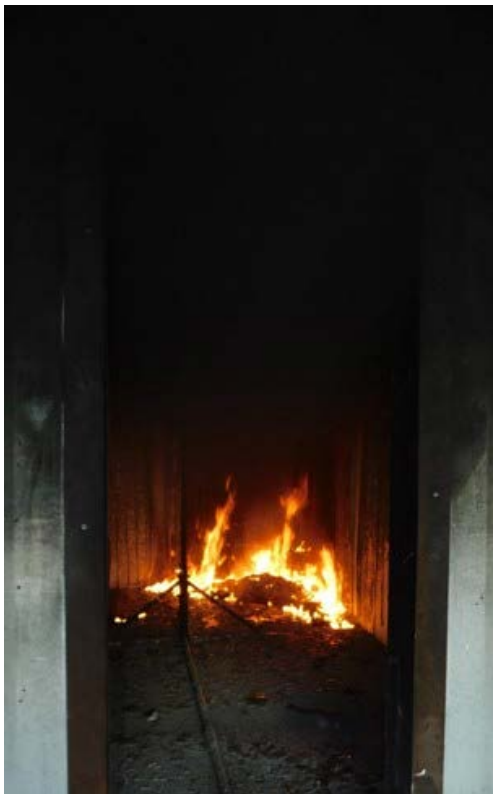
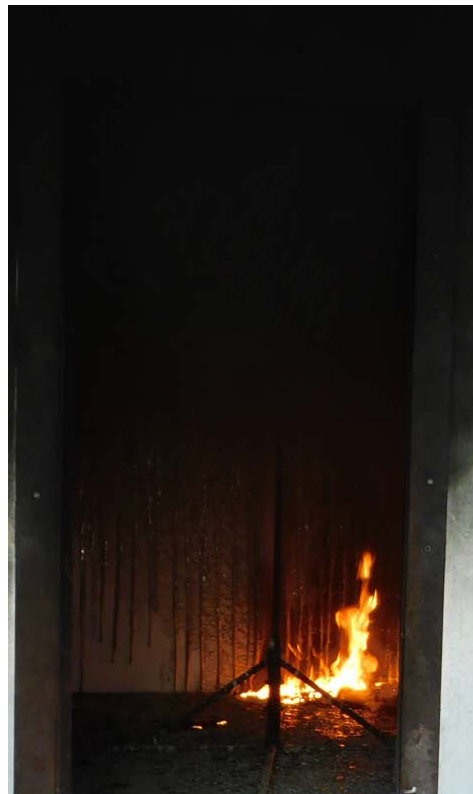
FIGURE 21:

22:01 INTO THE TEST

END OF TEST (23:23)

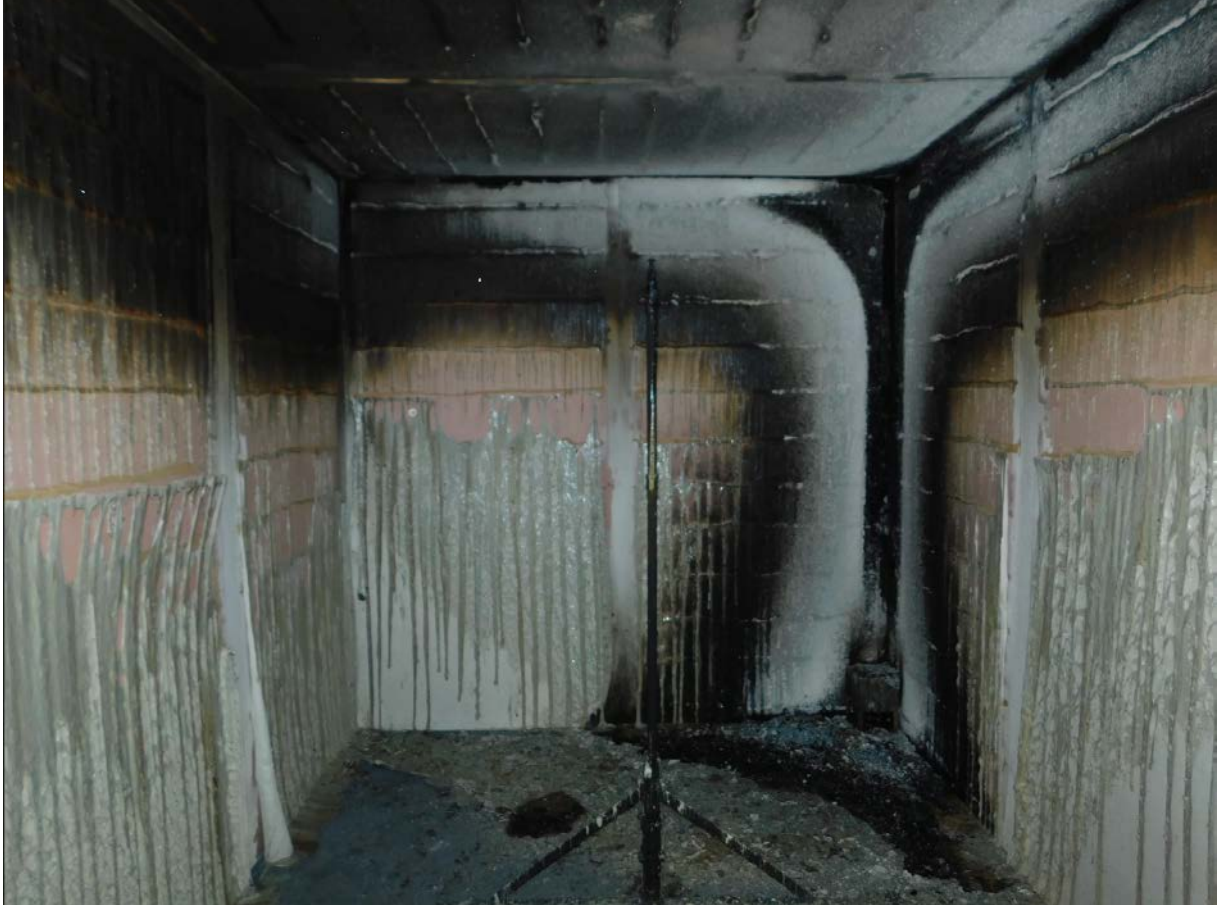
FIGURE 22:
POST TEST
