**Column Panels from Woven  
Image Pty Ltd**

**AS 5637.1 TEST REPORT  
TESTING TO AS ISO 9705:2003**

IGNL-8260-06-01R I01 R00

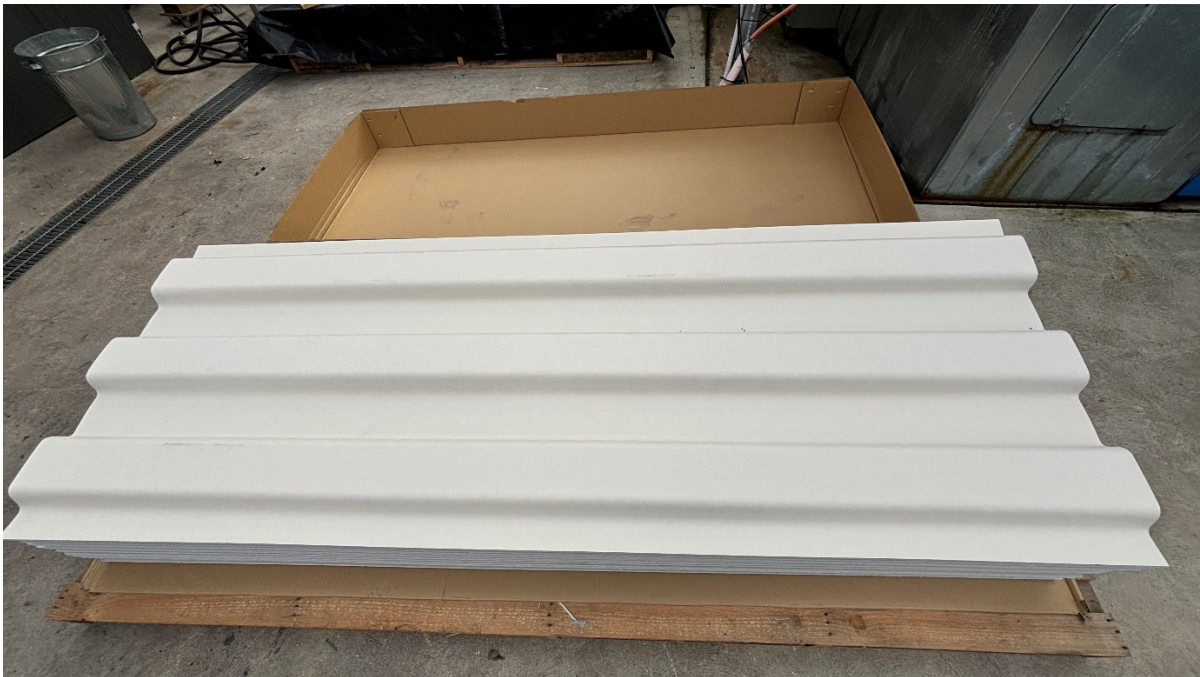
FIGURE 1:

The received specimens were corrugated Polyester felt panels. They had a measured thickness of 8.1 mm. They had dimensions of 1 m in width and 2.8 m in length. The corrugations extended along the entire length of each panel, with a nominal height of 75 mm and spaced at 150 mm centre.

SPECIMEN PANELS

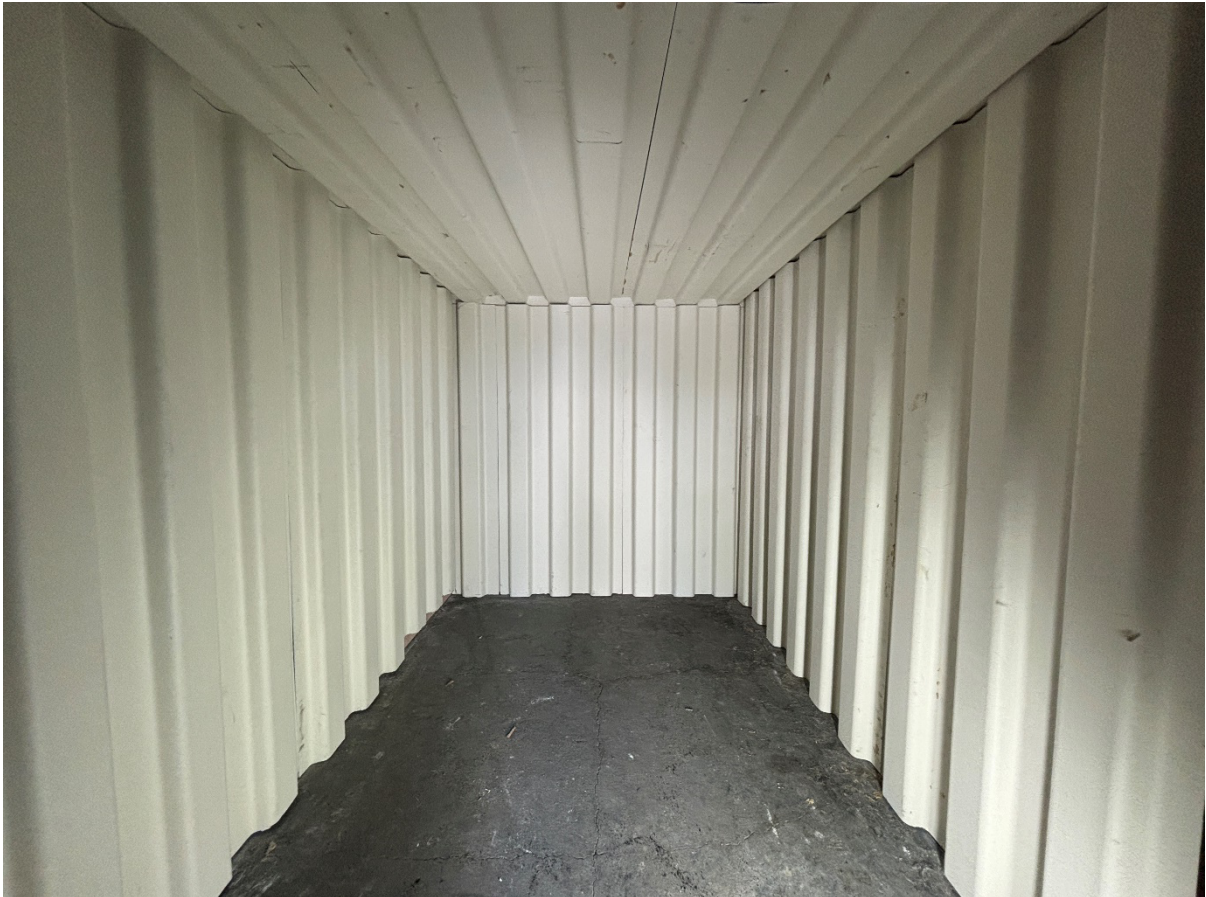
FIGURE 2:

The panels were fixed to the test room using H.B. Fuller Max Bond adhesive applied on the back of the panels. The panels were installed vertically and allowed to cure for two days before testing.

SPECIMEN INSTALLATION

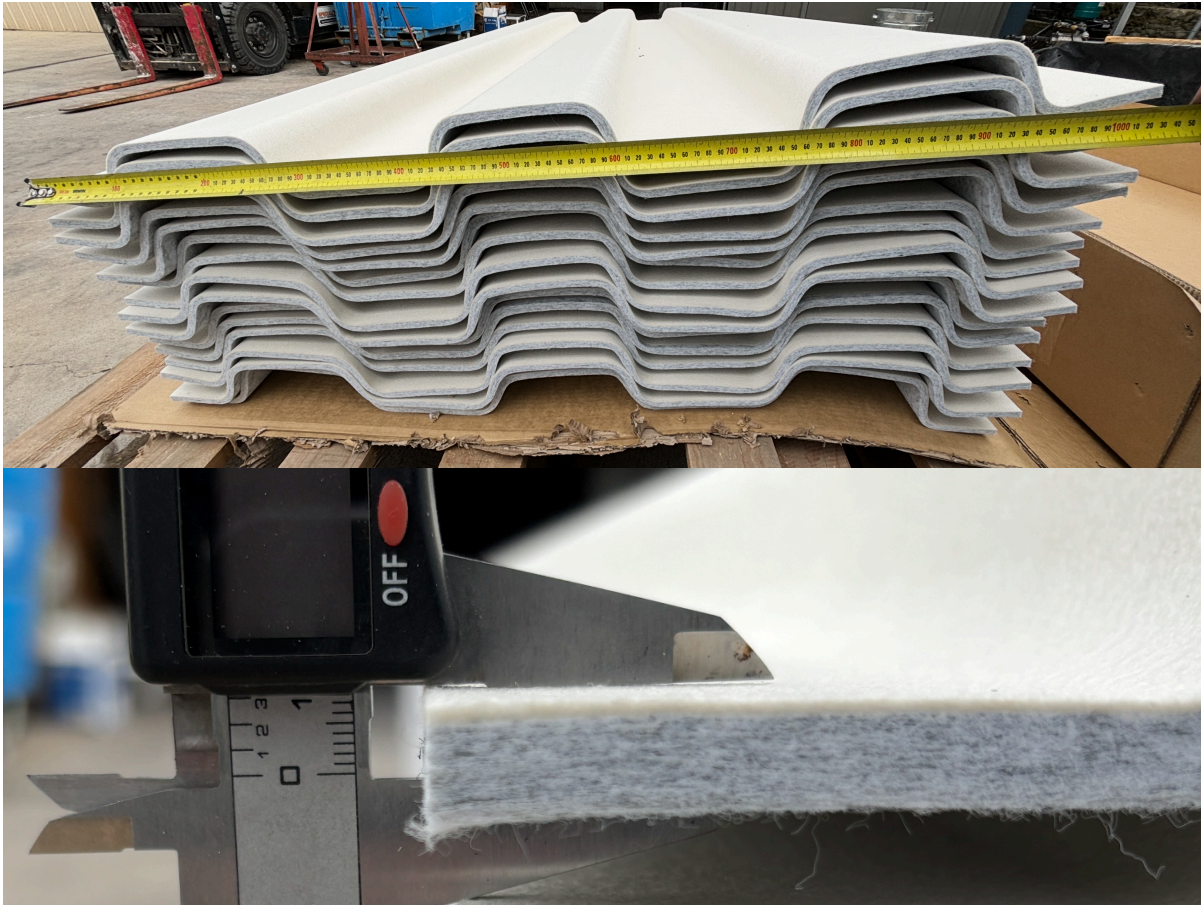
The received specimens were corrugated Polyester felt panels. They had a measured thickness of 8.1 mm and dimensions of 1 m in width and 2.8 m in length. The panel was comprised of two layers, a white top layer with a measured thickness of 2.61 mm and a grey bottom layer with a measured thickness of approximately 5.5 mm. The corrugations extended along the entire length of each panel, with a nominal height of approximately 75 mm and width of approximately 150 mm.

FIGURE 3:  
SPECIMEN PROFILE

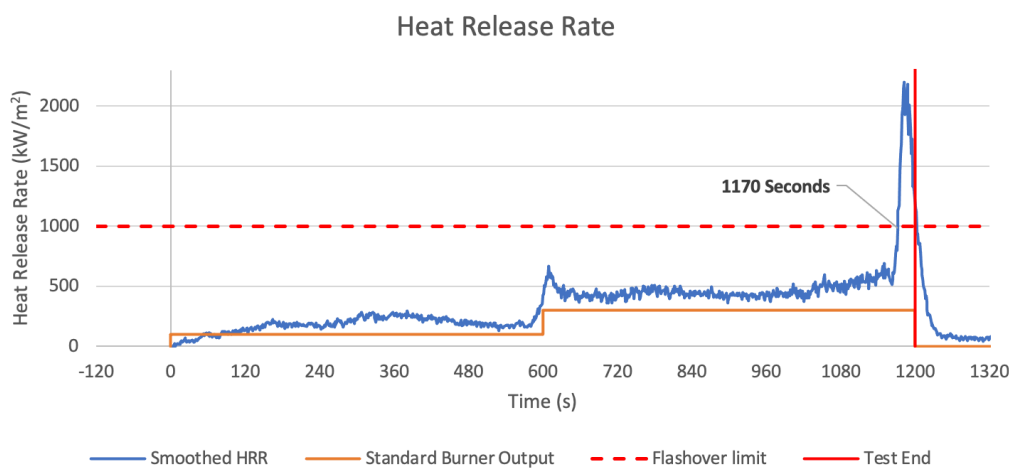
The heat release rate during the test is shown in the figure below. The heat release exceeded the flashover limit of 1 MW 1170 seconds into the test.

FIGURE 6:  
HEAT RELEASE RATE MEASUREMENTS

17:30	Thick black smoke was observed, puddle fire spread to fallen debris from the right-side wall.
17:40	Puddle fire split into 2.
19:34	1 MW heat output exceeded; flashover reached

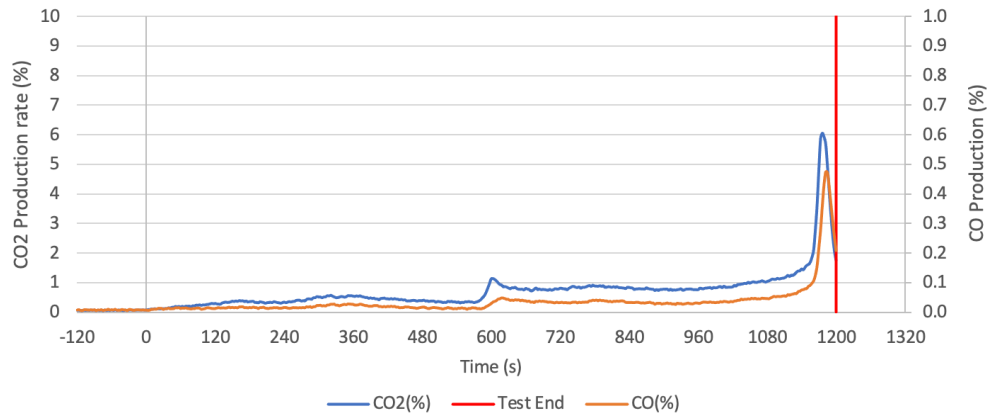
FIGURE 10:

An exhaust sampling probe sampled the combustion products which were analysed by a Servomex Servopro 4000 series analyser. Oxygen concentration during the test was determined by the paramagnetic oxygen analyser, whilst the carbon monoxide and carbon dioxide concentrations were determined within the Servopro 4000 analyser.

CARBON DIOXIDE AND CARBON MONOXIDE PRODUCTION

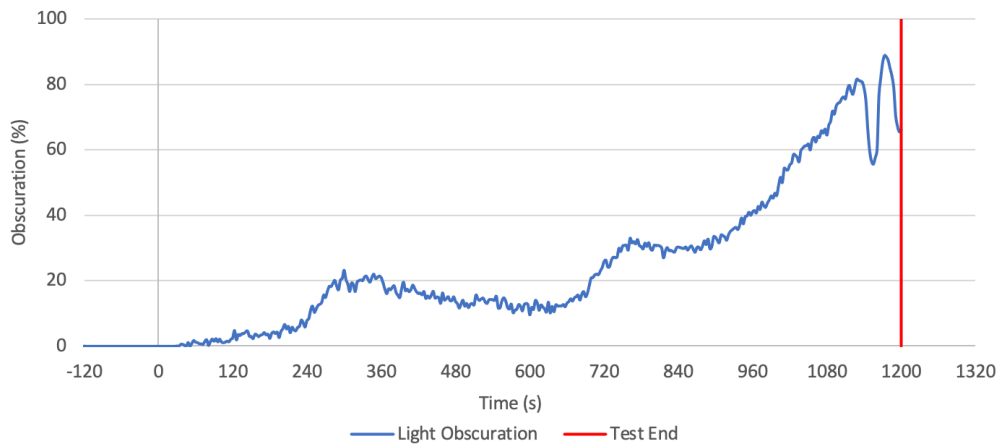
FIGURE 11:

Heat flux at the floor was not measured. The optical density of the smoke was determined by measuring the light obscuration with a system consisting of a laser lighter, lenses, an aperture and a photocell. No other variations to the test criteria were recorded.

LIGHT OBSCURATION MEASUREMENTS

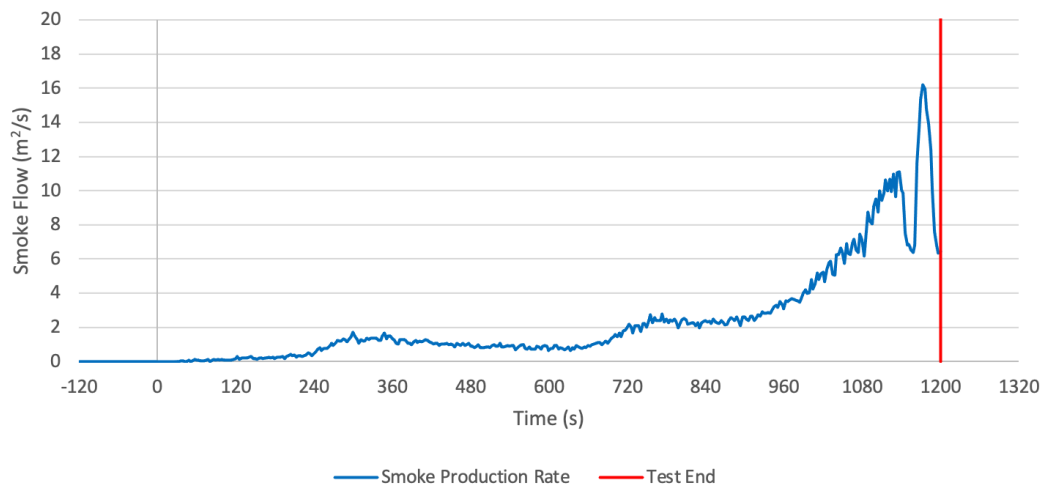
FIGURE 12:

SMOKE PRODUCTION MEASUREMENTS

Criteria	Result
Group Number	2
$SMOGR_{RC}$ (in m <sup>2</sup> s <sup>-2</sup> x 1000)	9.28

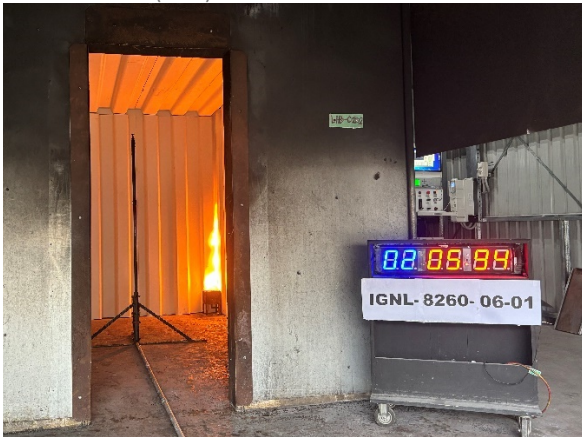
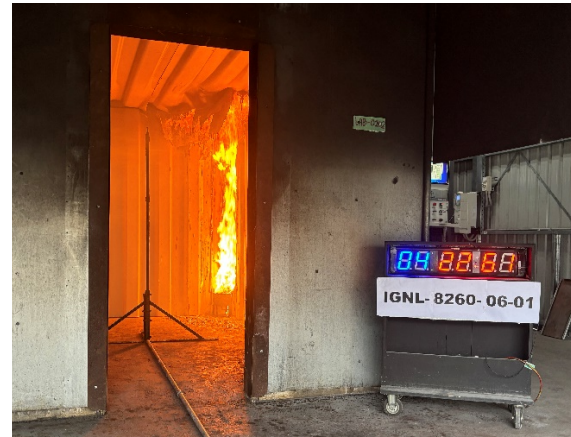
FIGURE 13:

START OF TEST (0:00)

02:30 INTO THE TEST

01:00	Plasterboard exposed in the burner corner; debris fell from the ceiling.
02:00	Panels peeled off the walls around the burner corner.
02:20	Puddle fire was observed under the burner.

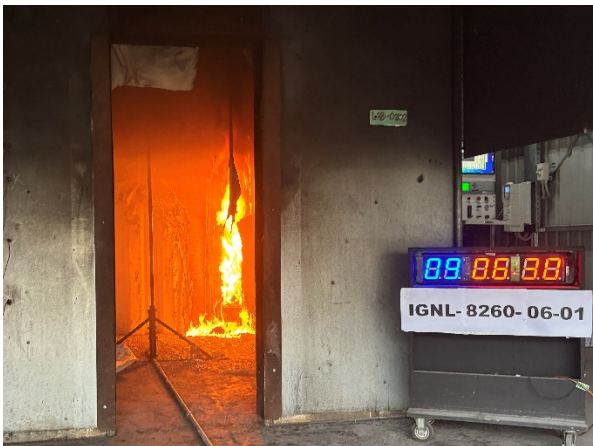
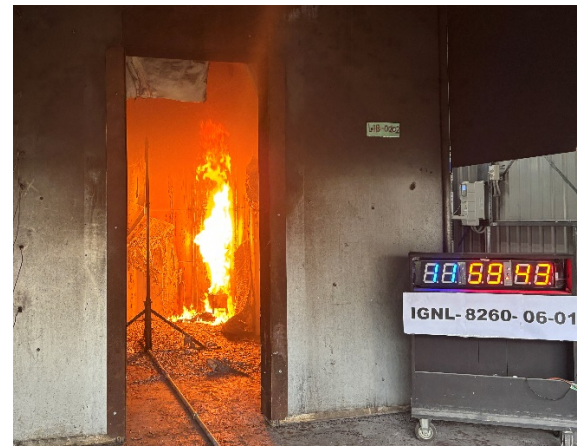
FIGURE 14:

07:06 INTO THE TEST

09:59 INTO THE TEST

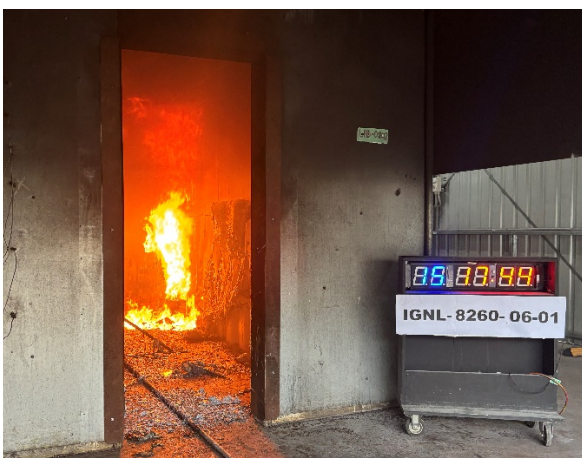
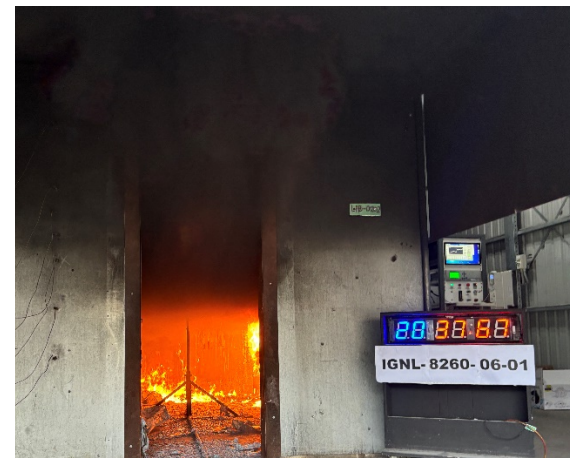
FIGURE 15:

13:17 INTO THE TEST

18:37 INTO THE TEST

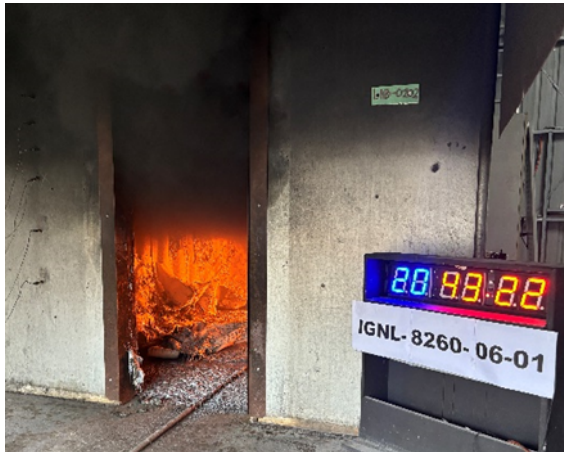
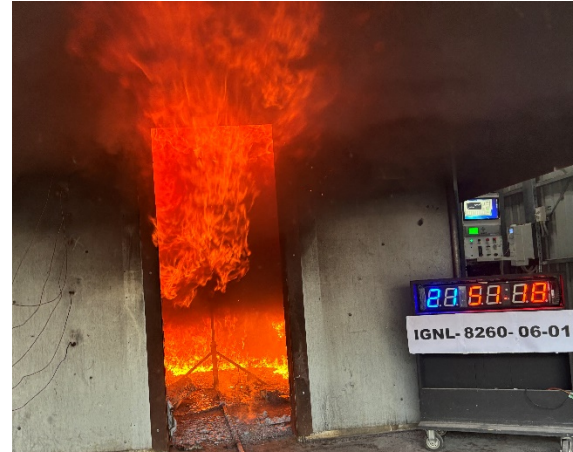
FIGURE 16:

18:43 INTO THE TEST (LEFT SIDE WALL)

19:51 INTO THE TEST

19:40	Flames was out of the door.
20:04	Test completed and burner off.
20:25	Fire extinguished.

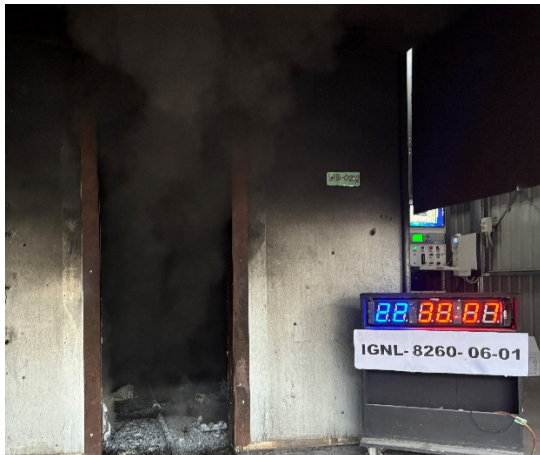
FIGURE 17:

END OF THE TEST

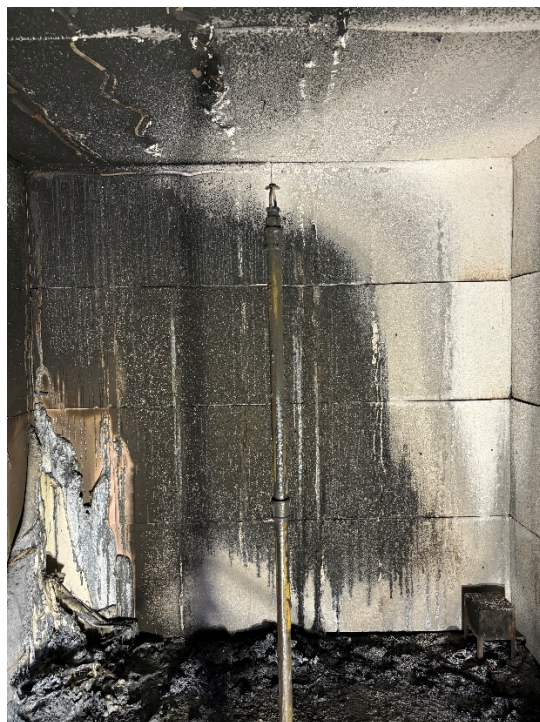
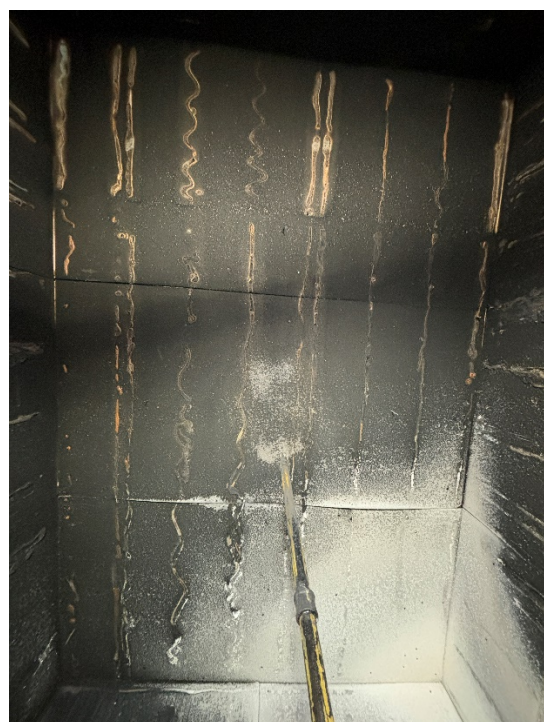
FIGURE 18:

POST-TEST (BACK WALL)

POST-TEST (CEILING)

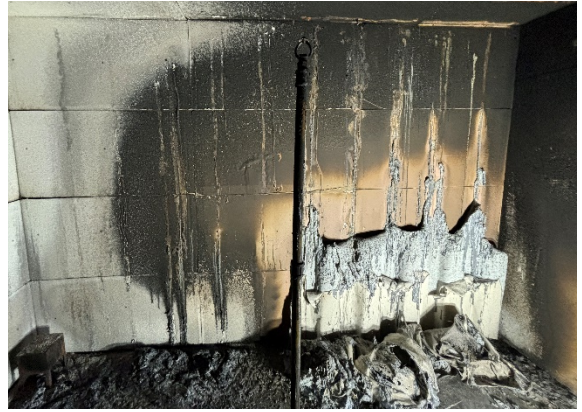
FIGURE 19:

POST-TEST (LEFT SIDE WALL)

POST-TEST (RIGHT SIDE WALL)
