**Client:** Woven Image Pty. Ltd.  
37-39 Chard Road, Brookvale, NSW 2766 Australia

## Measurement Type: Sound Absorption

## Test Specimen [Specimen area: 3.60 x 3.01 m = 10.82 m<sup>2</sup>]

**Name:** Woven Image Corrugated 3d Thermoform Wall Panel – Tested with no air gap and 25 mm thick polyester insulation in the cavity (high density face<sup>4</sup> to floor of test chamber).

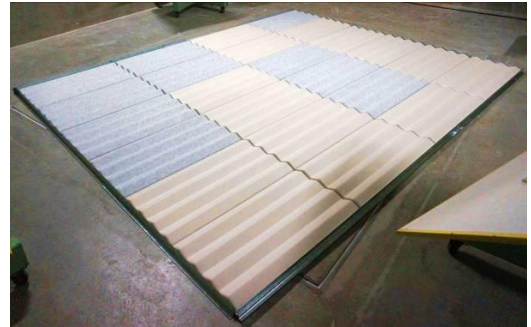
Test specimen installed in laboratory

- The reverberation chamber was swept and vacuumed to remove dust.
- The test specimen was installed directly on the concrete floor of the chamber with 25 mm polyester insulation installed in the void under the thermoformed panel – the insulation was resting directly on the floor of the test chamber with the high density side<sup>4</sup> facing down.
- The specimen for testing consisted of 24 complete panels and were arranged in a rectangle of dims 3.600 x 3.005 m (6 x 4 array), at an angle of 9° with the walls of the chamber (as per AS ISO 354).
- The perimeter edges of the test specimen were covered with a skirt of 1 mm thick folded steel angle, 50 mm high. Skirting members were pushed against the edges of the panels; pushing the panels against each other and minimising gaps at the skirt.
- Specimen installation was carried out by laboratory staff.

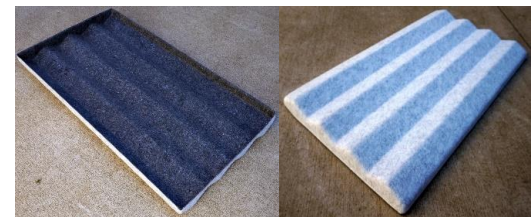
Front and underside of the 3d Corrugated Thermoform Wall Panel

- Specimen composition:
  - Top Layer: 100% PET (60% recycled), thickness: 1.90 ± 0.25 mm, surface density: 350 gsm – detail image of sound-incident face at right; 2 colours comprised the test sample: 'Vanilla' (Woven Image ref. 908 – bottom image at right) and White base w/ Dark fibres (Woven Image ref. 501 – Top image at right)
  - Bottom Layer: 100% PET (70% recycled), thickness: 2.50 ± 0.25 mm, surface density: 1000 gsm; charcoal coloured
  - Binding agent: Laminated with low melt scatter glue @ 25 gsm
  - Infill installed in cavity @ underside of panel: 25 mm polyester insulation, Indiv. Infill baffle dims.: 25 x 480 s 895 mm, surface density: 2370 gsm (meas.) as per Woven Image specification.
- Supplied for testing as discrete panels of individual dimension nom. 900 x 500 x 25-50 mm

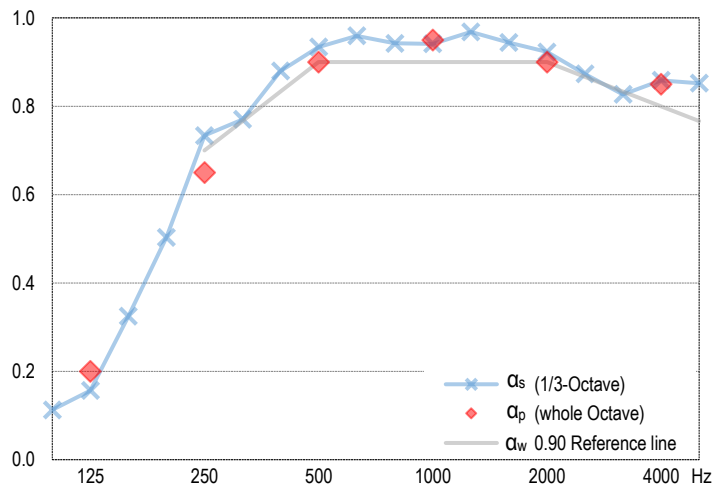
Freq (Hz)	Absorption coefficient		Reverberation times, T <sub>60</sub> (s)	
	α <sub>s</sub>	α <sub>p</sub>	Empty room	with Specimen
100	0.11		6.39	5.16
125	0.16	0.20	7.09	5.19
160	0.32		6.95	3.98
200	0.50		6.49	3.12
250	0.73	0.65	5.57	2.37
315	0.77		6.61	2.46
400	0.88		6.62	2.26
500	0.93	0.90	6.05	2.11
630	0.96		5.98	2.06
800	0.94		5.48	2.02
1000	0.94	0.95	5.26	1.99
1250	0.97		4.68	1.87
1600	0.94		4.16	1.81
2000	0.92	0.90	3.72	1.74
2500	0.87		3.29	1.69
3150	0.83		2.92	1.63
4000	0.86	0.85	2.44	1.45
5000	0.85		1.93	1.26

α<sub>w</sub> = 0.90

SAA = 0.86

NRC = 0.90
